Service Bulletin

Subject: Additional Diagnostics For DTC P0420 And Or P24A0

Models: 2010 - 2015 Chevrolet Express

Equipped with the 6.6 Duramax Diesel Engine (RPO codes LML and LGH)

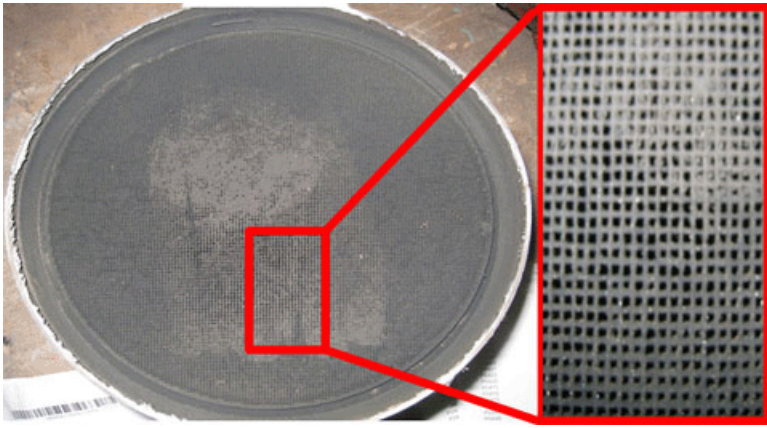
Cut Away View Of Normal DOC

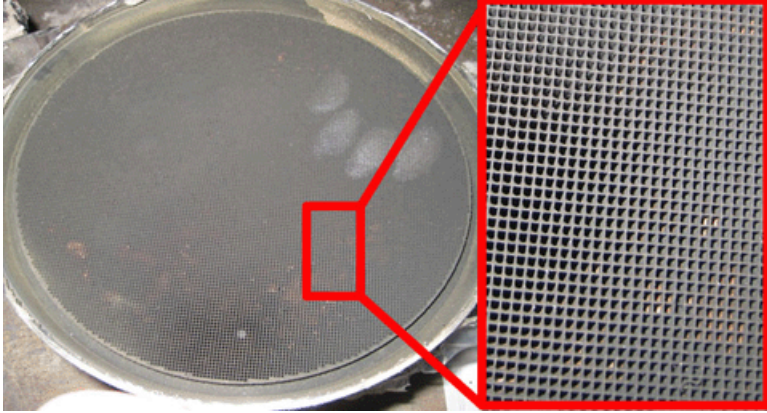
Cut Away View Of Normal DOC

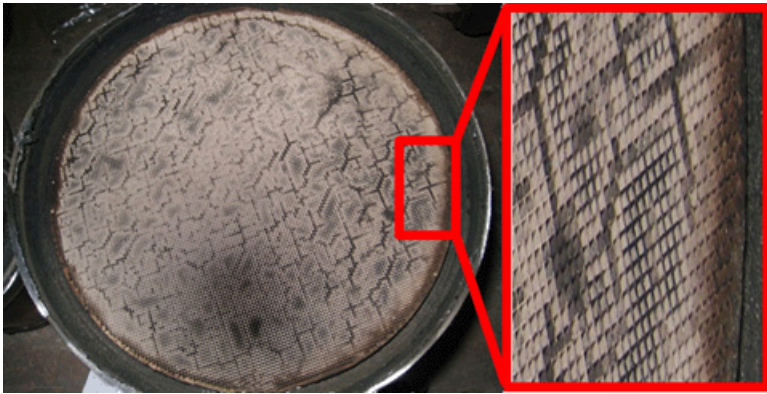
Cut Away View Of Distressed DOC

If the DOC shows signs of distress as shown above, replace the DOC.

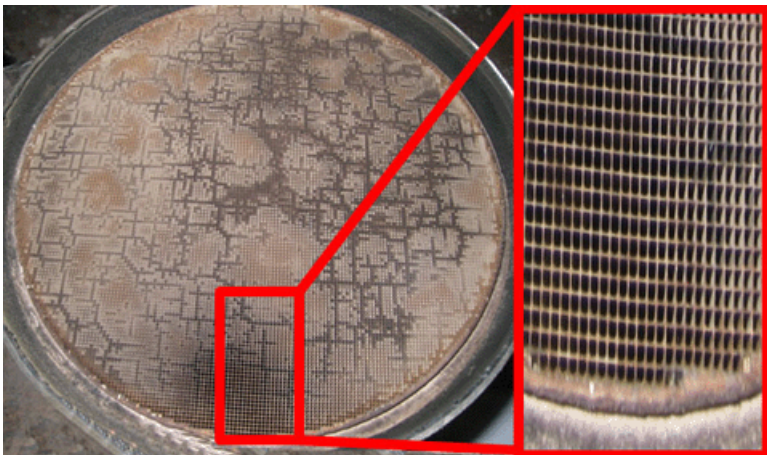
Cut Away View Of Distressed DOC

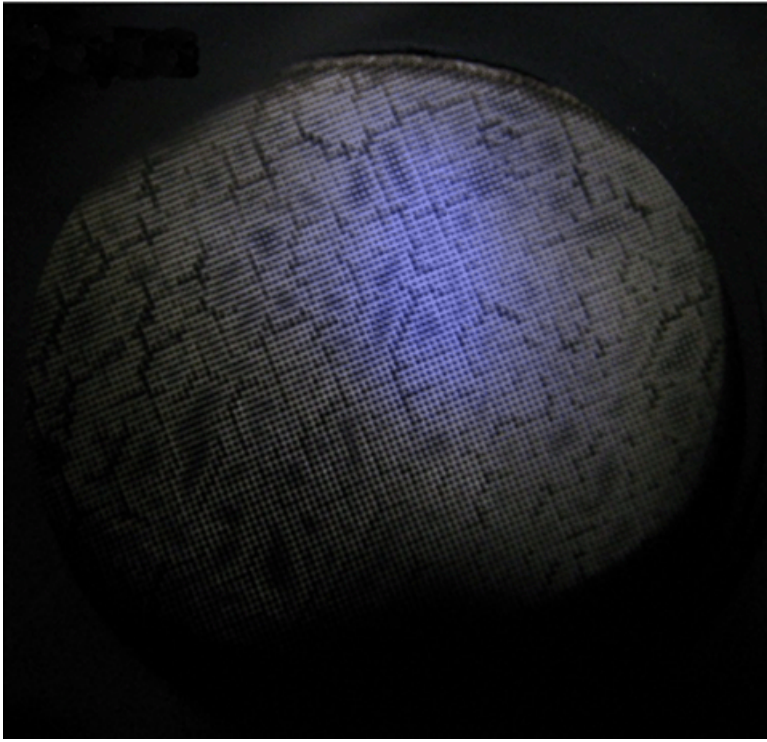
View Of Distressed DOC's Downstream (Outlet) Face (As Seen By Looking At The Catalyst Through The DOCs 4 Bolt Flange Opening)
