# Service Bulletin

## PRELIMINARY INFORMATION

**Subject:** Rear Fascia Sticks Out Past Rear Tail lamp Assembly

**Models:** 2014 Cadillac CTS Sedan "VIN A"

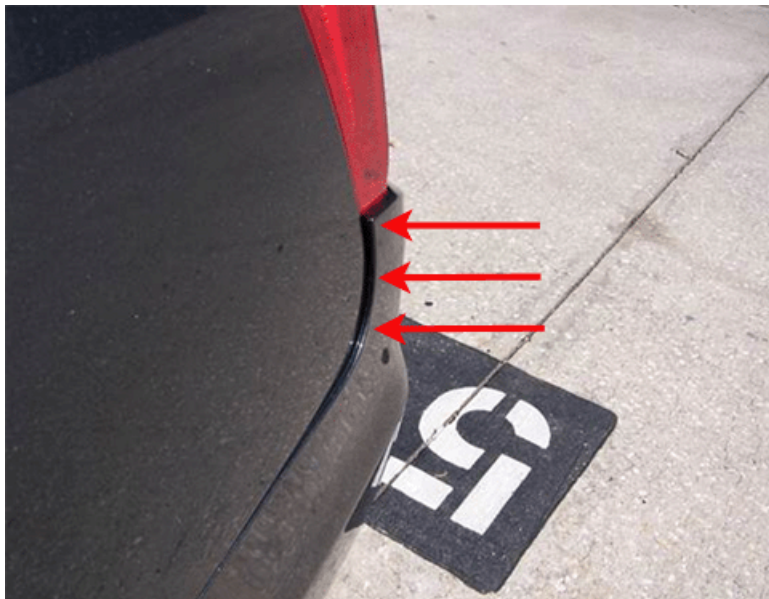
A customer may comment that the rear fascia or bumper cover sticks out past the tail lamp lens as per picture below

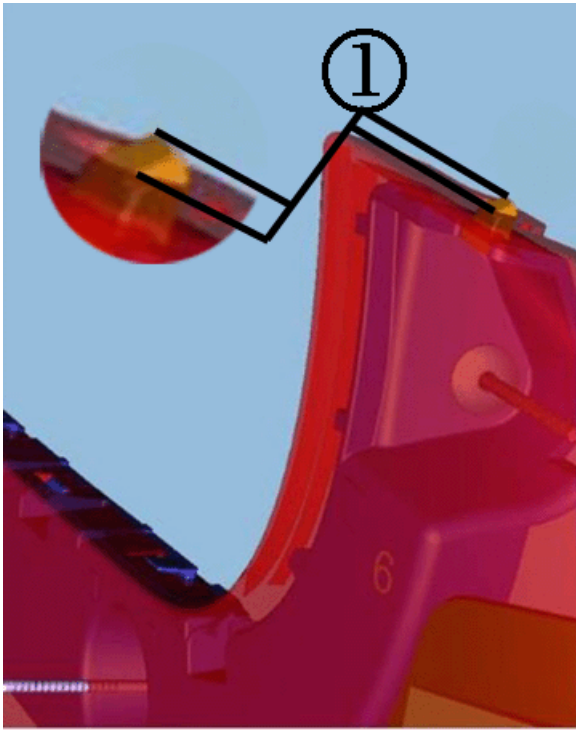
1. Remove the tail lamp from the same side of the vehicle with the fascia fit concern, being careful not to scratch the fascia
2. Inspect and measure the fascia retaining clip protrusion through the bracket to see if it measures 1.5mm as shown in the image below (might have to push the fascia back in installed position to measure the retaining clip protrusion if it is not engaged).

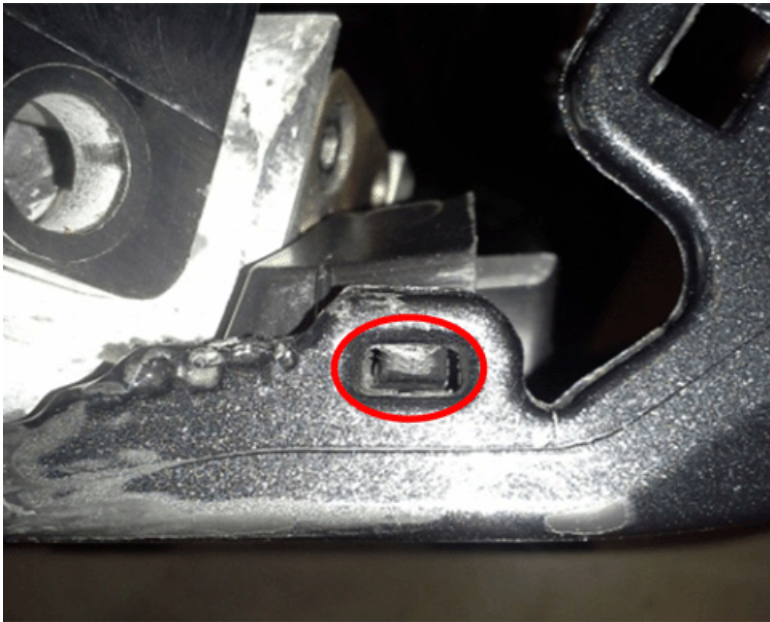
Loosen or remove the rear fascia to inspect for flashing in the mounting hole(s) that may be preventing the pin on the bracket from retaining the fascia properly as per PIC below.

While the fascia is removed, remove the flashing if any, and install the fascia to see if removal of the flashing resolves the issue. If flashing is not the cause or has been removed and the fascia clip still does not fully engage into the bracket, the bracket may need to be replaced.

**Note:** Do not replace the fascia for this condition unless the fascia flange is damaged.
