Bulletin No.: PIT5059B

PRELIMINARY INFORMATION

Subject: Roof Beacon Inoperative (Switch Disconnected)

Models: 2011-2013 Chevrolet Silverado, Tahoe, Suburban

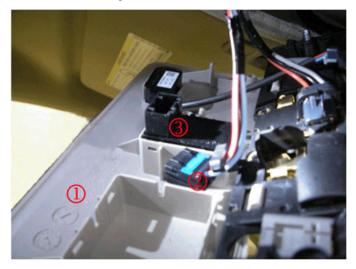
Starting with the 2011 models the roof beacon switch will be left disconnected from the assembly plant. This is to eliminate the risk of a dead battery if the switch is accidentally left on with the ignition key off.

- 1. Overhead console
- 2. Beacon Switch Connector
- 3. Beacon Switch

When a roof beacon light is added, the switch will need to be connected, see picture below.
