Service Bulletin

Bulletin No.: PI0564F

Date: November, 2014

Subject: Wax Coating on Frame Peeling, Metal Shows Corrosion/Rusting

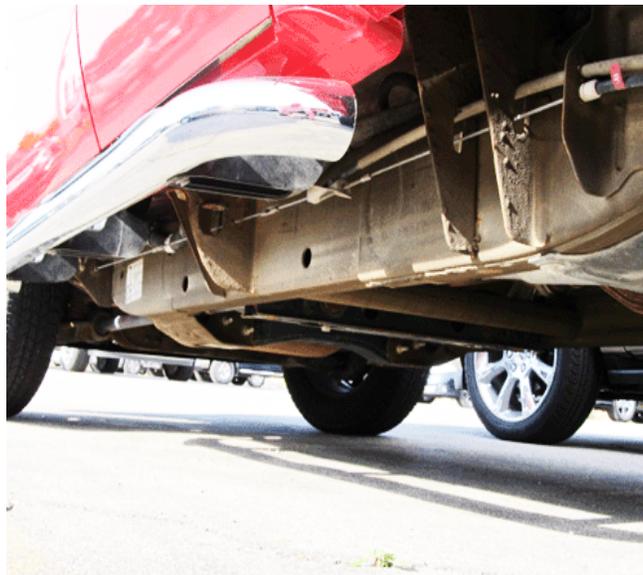
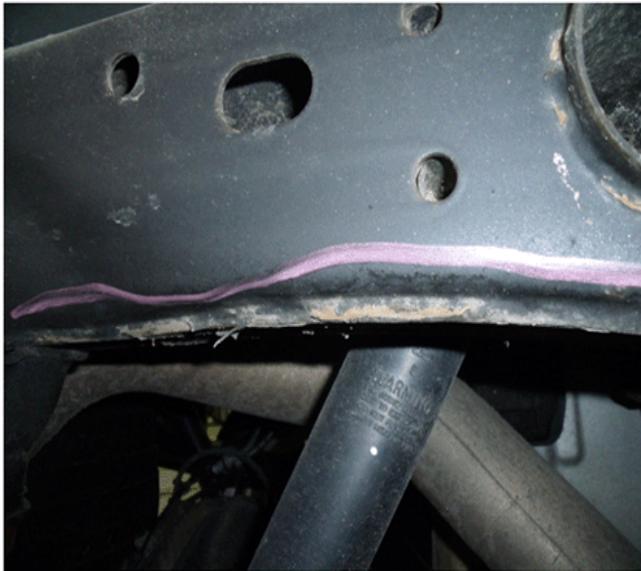
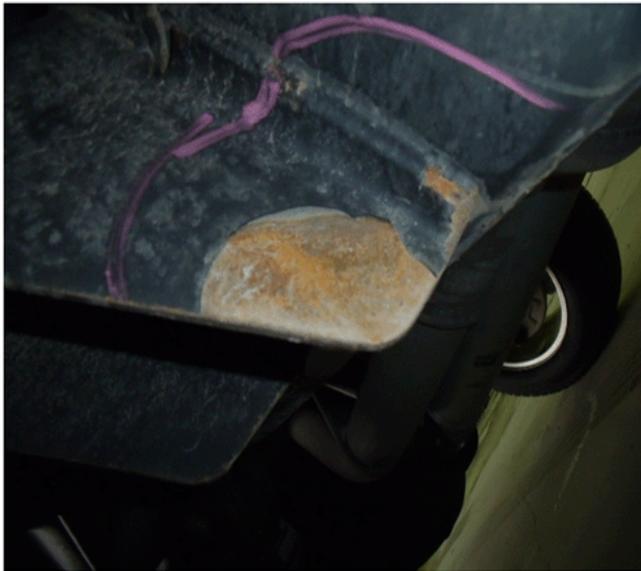
Some customers may comment that areas of the frame wax coating are peeling off and rust/corrosion is visible on the metal in these areas. Several examples of this condition are shown in each group of graphics below.

A combination of specialized metal coating products manufactured by Lloyds and Daubert have been found to be the most suitable products to provide corrosion control and protection to address this type of repair. Our recommendation is to prep the metal surface using *Lloyd's Pure Prep™ Metal Surface Preparation P/N 25418, then topcoat with both *Lloyds Kryptonite Metal Treatment P/N 36502 Life Long Rust Protection and *Daubert Non-Rust® P/N X-121B One Coat Rust Preventative Coating. It is strongly recommended they be applied according to the manufacturer's procedures.
