Service Bulletin

Bulletin No.: 10-06-01-008L

Subject: Engine Oil Consumption on Aluminum Block/Iron Block Engines with Active Fuel Management (AFM) (Install AFM Oil Deflector and Clean Carbon from Cylinder and/or Install Updated Valve Cover)

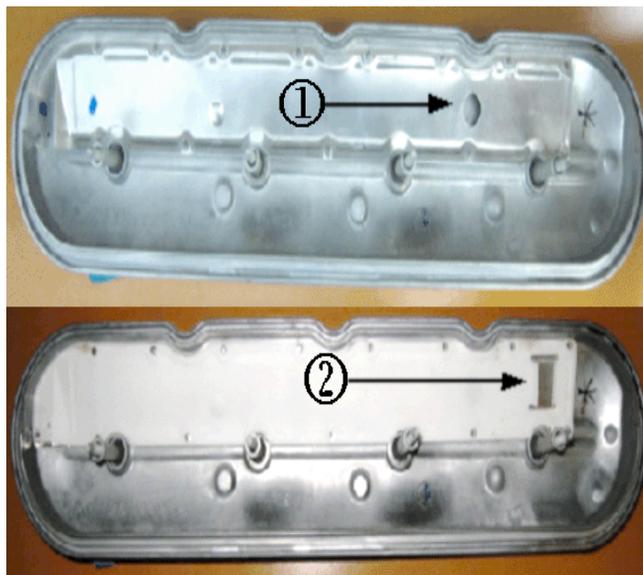
2740641

- 1) Old Design
- 2) New Design

PCV pullover or an overactive lifter can cause oil to be pulled through the PCV system even at low vehicle mileage. A correctly functioning PCV system will only leave a film of oil in the intake manifold. Inspect the intake manifold to see if there is any oil puddling in the bottom. If there is you will need to replace the left valve cover. Two new left rocker arm covers have been released for trucks and vans. Technicians should replace the left rocker arm cover with GM P/N 12570427 for 2007-2008 or GM P/N 12642655 for 2009-2011. Refer to the Parts Information below for the Camaro. This rocker arm cover has a relocated PCV drain hole that prevents oil from entering the intake manifold. Refer to Valve Rocker Arm Cover Replacement - Left Side in SI.

Note: These rocker covers are for specific years. The PCV orifice is different for each. The correct cover must be used or an SES light may set.
