# Service Bulletin

Bulletin No.: PI1357

**Subject:** Air Bag Light On, Service Air Bag Message Displayed on DIC

**Models:** 2014-2015 Buick Enclave  
2014-2015 Chevrolet Traverse  
2014-2015 GMC Acadia

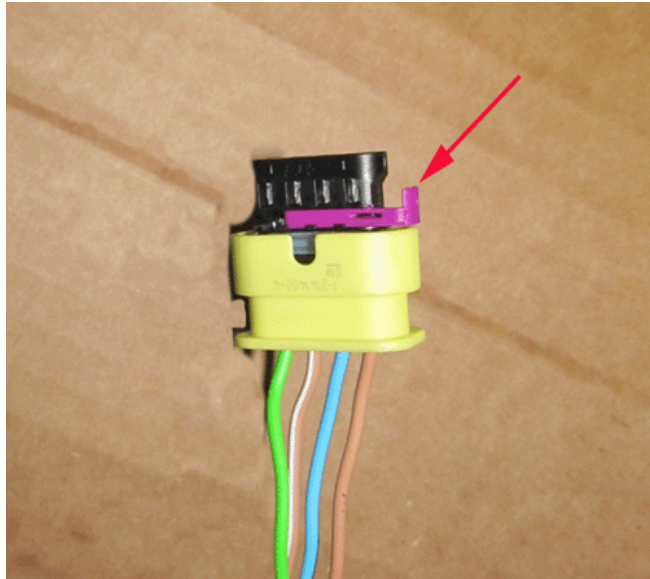
3990716

**Note:** A yellow 4-way connector (passenger) as shown above is similar to the 6-way yellow connector (driver).

5. Remove the terminal position assurance (TPA) lock as shown above.

**Note:** Always use care when removing a terminal position assurance (TPA) in order to avoid damaging it.

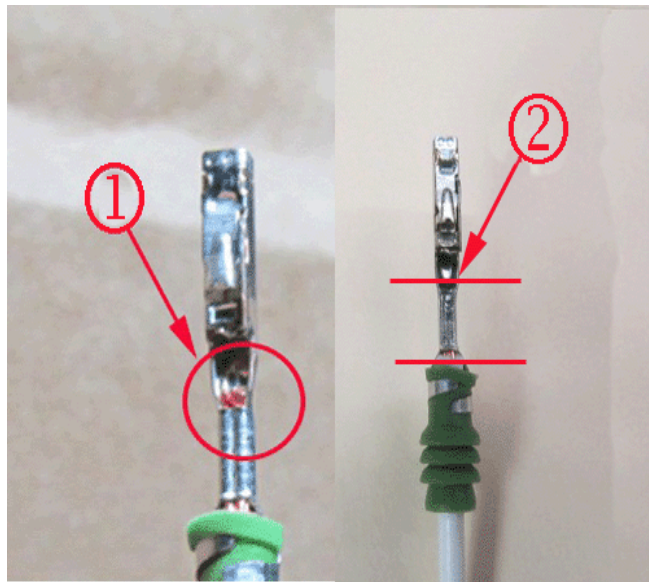
4009530

This condition may be caused by high resistance due to the crimping of the terminals in the front seat X333, X332, F106D, F106DA and F106P connectors.

6. Remove each terminal using the J-38125-12A and add a small amount of solder to the crimp.
  - Point the terminal upward so the solder does NOT flow into terminal.
  - Cover the exposed wires (1) with solder in the terminal.
  - Fill the crimp of terminal with solder (2).

**Caution:** Use of a small amount of solder is required or possible terminal damage or improper terminal fit into connector could result.

**Note:** Use rosin core lead solder. The higher the lead content the better as it has lower melting point.

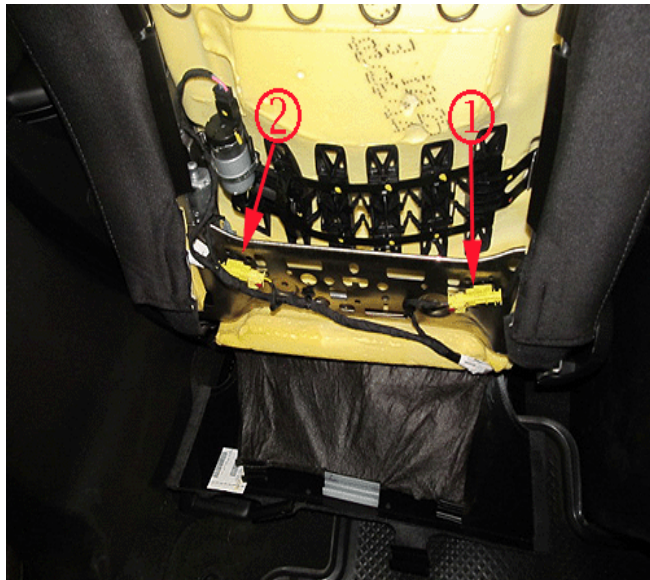
4009158

**Note:** The illustration above is of the driver's seat. The passenger seat will only have the seat airbag outboard connector (2) on the right side of the seat.

14. Disconnect the front seat back airbag inboard (1) and/or outboard (2) connector(s).
15. Perform steps 5 through 8 to the connector(s).
16. Reconnect the inboard and/or outboard connectors.
17. Enable the SIR system. Refer to the SIR Disabling and Enabling in SI.
18. Clear any sensing and diagnostic module (SDM) DTCs using a scan tool. Verify that the airbag indicator is NOT displayed on the instrument panel cluster (IPC). If DTCs appear after clearing the SDM, refer to the appropriate diagnostic information in SI.
