# Service Bulletin

Bulletin No.: 10-06-01-008M

**Subject:** Engine Oil Consumption on Aluminum Block/Iron Block Engines with Active Fuel Management (AFM) (Install AFM Oil Deflector and Clean Carbon from Cylinder and/or Install Updated Valve Cover)

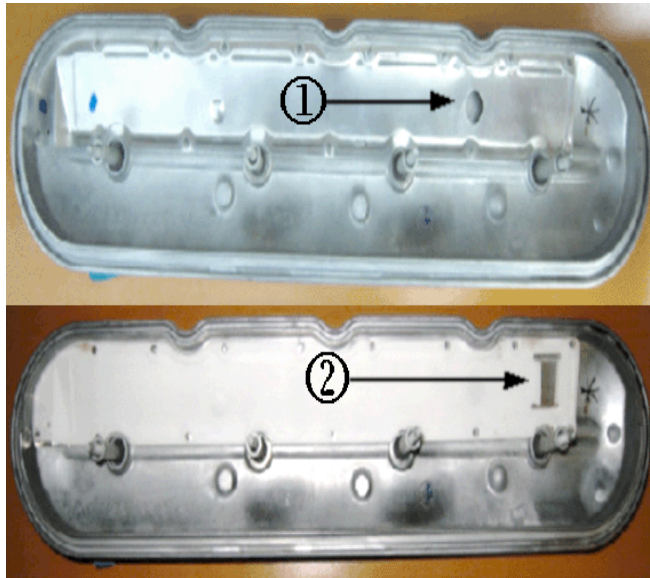
2740641

- 1) Old Design
- 2) New Design

PCV pullover or an overactive lifter can cause oil to be pulled through the PCV system even at low vehicle mileage. A correctly functioning PCV system will only leave a film of oil in the intake manifold. Inspect the intake manifold to see if there is any oil puddling in the bottom. If there is you will need to replace the left valve cover. Two new left rocker arm covers have been released for trucks and vans. Technicians should replace the left rocker arm cover with GM P/N 12570427 for 2007-2008 or GM P/N 12642655 for 2009-2011. Refer to the Parts Information below for the Camaro. This rocker arm cover has a relocated PCV drain hole that prevents oil from entering the intake manifold. Refer to Valve Rocker Arm Cover Replacement - Left Side in SI.

**Note:** These rocker covers are for specific years. The PCV orifice is different for each. The correct cover must be used or an SES light may set.
