Service Bulletin

Bulletin No.: P11327

Subject: Water Present at Driver's Foot Well

Models: 2014 Chevrolet Equinox
2014 GMC Terrain
Vehicles Built Between March 17, 2014 and May 15, 2014

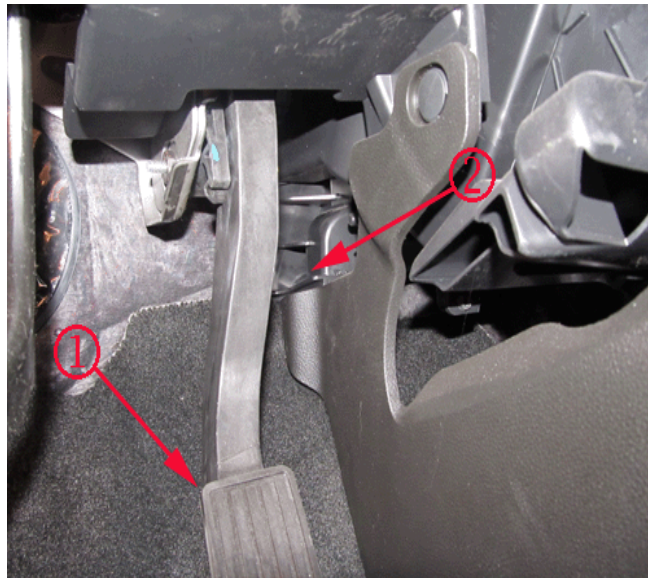
3989781

This may be due to a void/hole near the heater and air conditioning evaporator and blower module drain.

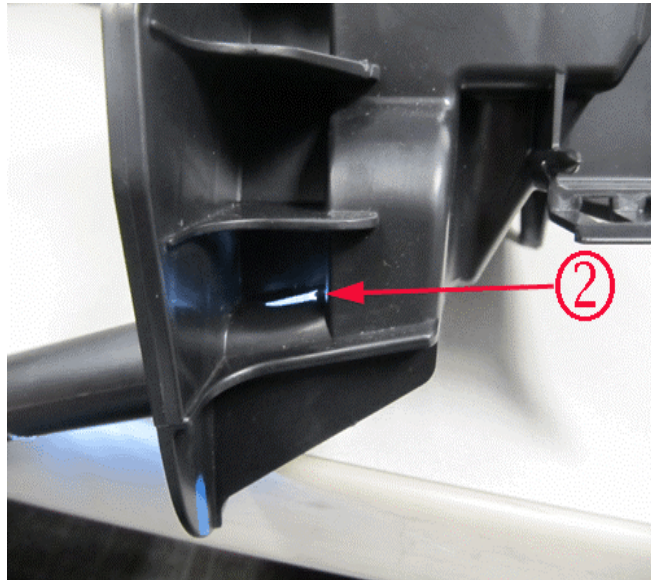
3989947

If a void/hole (2) is found in the lower HVAC case, next to the accelerator pedal (1), proceed with the instructions below.

1. Prepare the cavity by sanding with 80-100 grit sandpaper.
2. Clean the cavity with an alcohol prep wipe. Allow to dry before going to the next step.
3. Cut approximately 50 mm (2 in) from the 3M™ Ribbon Sealer or equivalent.
