Service Bulletin

Bulletin No.: PIE0316

Subject: Engineering Information – Battery Saver Active Message Displayed on DIC, Drive Motor Generator Belt Broken, DTC P1A6F or P0A90 May be Set

Models: 2013-2014 Buick LaCrosse, Regal
2013-2014 Chevrolet Malibu
Equipped with eAssist (RPO LUK)

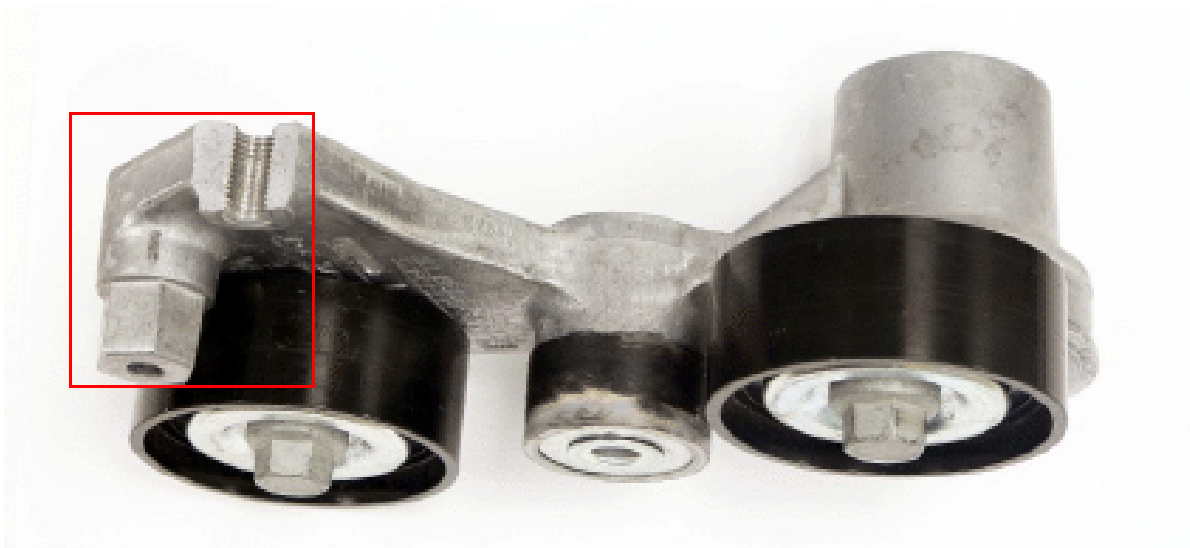
3973868

Further inspection may reveal that the drive motor generator unit (MGU) belt is broken or the tensioner is broken at the hydraulic tensioner attachment boss (shown below).

If you encounter a vehicle with the above concern, inspect the MGU belt and tensioner. If the belt looks like it was cleanly snapped or if the tensioner is broken at the attachment boss (shown below), contact the engineer listed below for further instructions.
