# Service Bulletin

Bulletin No.: PI1199A

## PRELIMINARY INFORMATION

**Subject:** Engine Cranks But Does Not Start, Engine Cranks With Loud Backfire, Engine Will Start and Stall, Engine Cranks with Hissing Noise from Tailpipe or Buzz, Pop, Rattle or Whistle Noises Occur

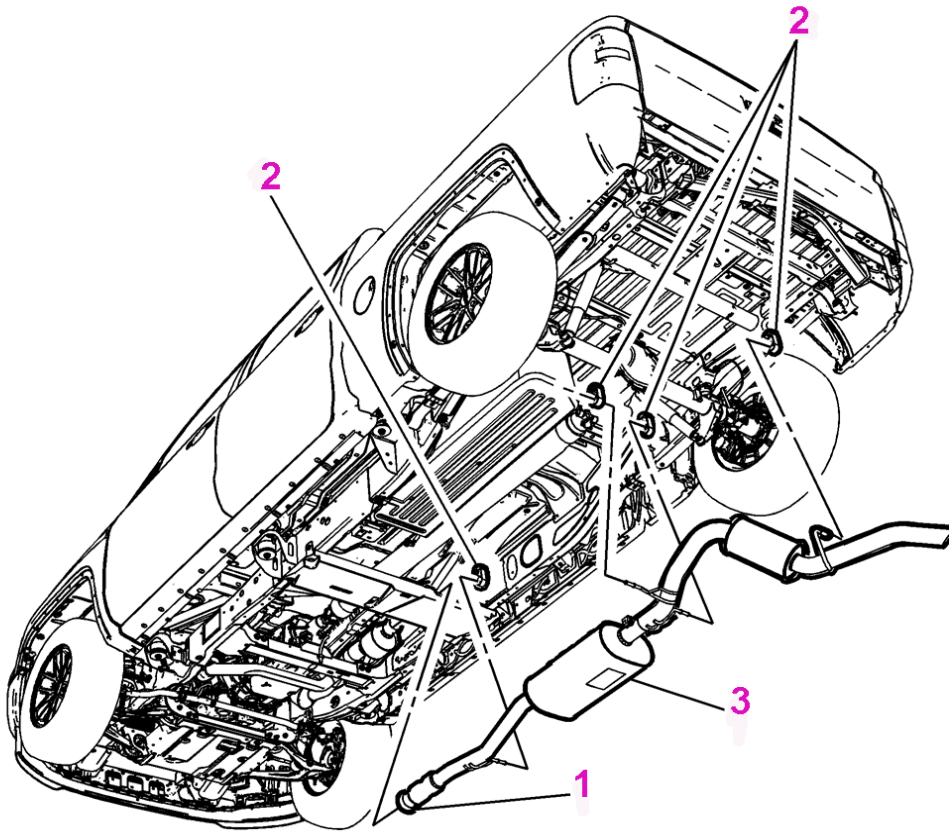
3709109

3. Exhaust system part identification:

- Exhaust Muffler Clamp Fastener (1)
- Exhaust Muffler Isolators (2)
- Exhaust Muffler (3)

4. Replace the exhaust system. Refer to Exhaust Muffler with Resonator, Exhaust, and Tail Pipe Replacement in SI and the Parts Information in this PI.

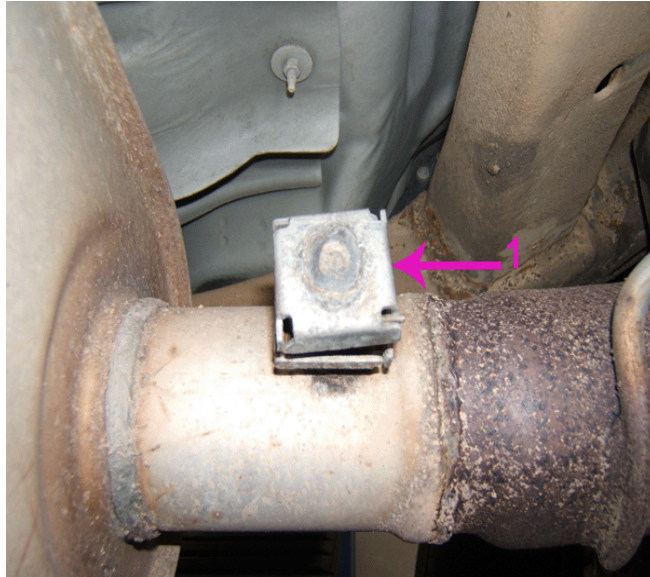
3965082

Typical exterior view of the PEV (1) in its normal partially open position, with the engine turned **OFF**.
