Service Bulletin

Bulletin No.: P11328

Subject: Diagnostic Tip – Grind or Rattle Noise During a Left Turn or on a Bump

Models: 2013-2014 Cadillac CTS (VIN D), Escalade Models
2013 Chevrolet Avalanche
2013-2014 Chevrolet Camaro, Caprice, Corvette, Express, Silverado, Suburban, Tahoe
2013-2014 GMC Savana, Sierra, Yukon Models
Equipped with 6L80 Automatic Transmission (RPO MYC)

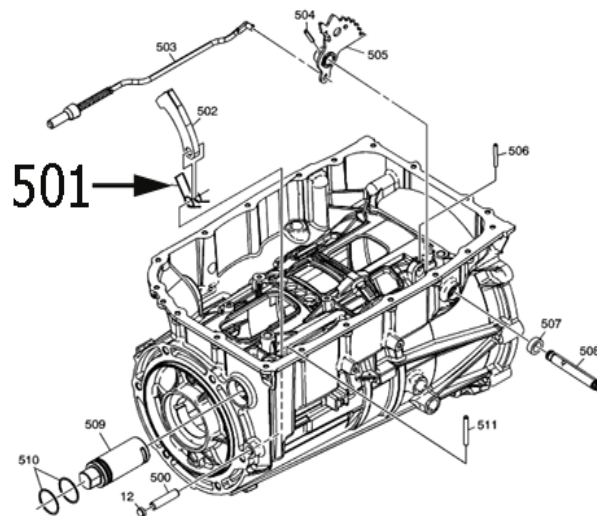
3982750

This noise may be due to a separated park pawl return spring, allowing the park pawl to pivot into the rotating park gear.

Remove the transmission fluid pan and inspect for a broken park pawl return spring (501).

A broken pawl return spring (501) will typically be loose on the park pawl shaft (500), while an unbroken spring will press tightly against the park pawl and the case.

Pieces of the spring may be found on the magnet or in the pan or filter.

If the park pawl return spring is broken, the **transmission case** must be replaced as the park pawl spring is not serviced separately.
