Service Bulletin

Bulletin No.: P11331

Subject: Incorrect Icon for Power Assist Step/Running Board Switch

Models: 2015 Chevrolet Suburban, Tahoe
2015 GMC Yukon Models
Equipped with RPOs BRS, JF4, UFL (EXC JHD)

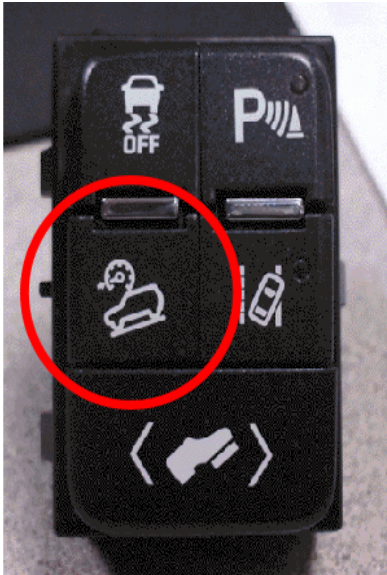
3995324

During PDI Inspection it may be noticed that the multi-switch pod located left of the instrument cluster may be missing the power assist step/running board switch. The typical location for this switch may instead show hill descent control.

Some vehicles may have been built with the correct switch part number but produced with the wrong icon for the power assist step/running board button as shown below.

(1) Incorrect Icon

If identified as having an incorrect icon, technicians should replace the switch pod using the part number listed below. Refer to Vehicle Stability Control System Switch Replacement in SI.

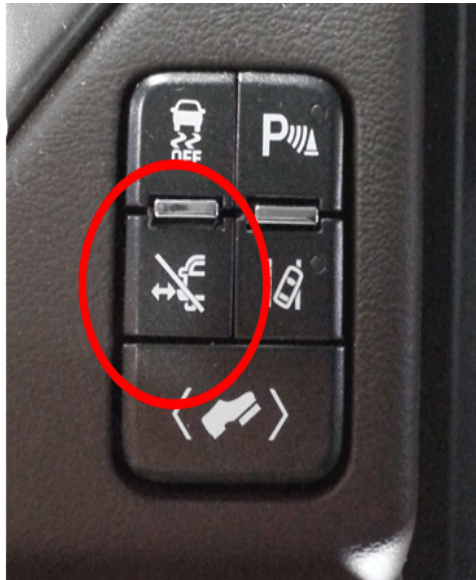
3995325

(2) Correct Icon
