Service Bulletin

Bulletin No.: 14-06-04-002A

Subject: Information for No Start Due to Inoperative LPG Fuel Pump Resulting from Upfitter Modifications

Models: 2012-2015 Chevrolet Express
2012-2015 GMC Savana
Equipped with Liquefied Petroleum Gas (LPG) – RPO KO7

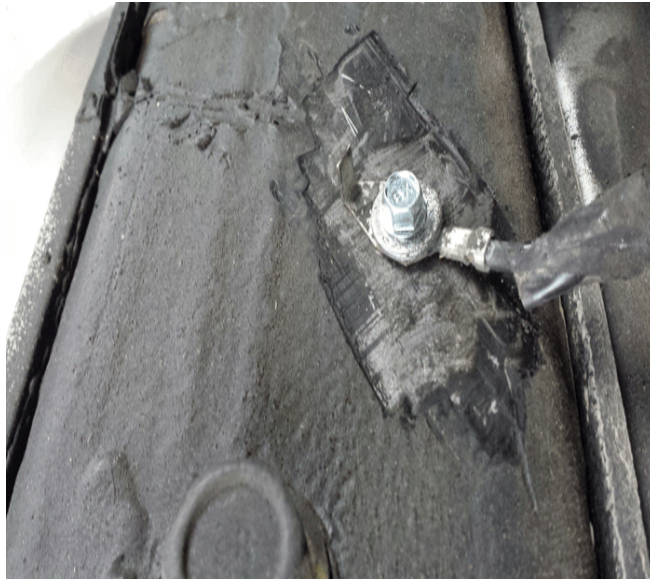
2. Review the graphics of the several new G400 locations that were possibly selected for use by the upfitter on the chassis frame in order to become familiar with the various locations.

3. Using GM approved residue-free solvent or equivalent, remove any grease from the G400 terminal.
4. Disconnect and remove the G400 terminal from the chassis frame.

5. Carefully remove any corrosion from both sides of the G400 terminal.
6. Using GM approved residue-free solvent or equivalent, remove any grease from the area and allow to dry.

7. Carefully remove any factory coating from the area until clean bare metal is visible.
8. Prep the repair area, as outlined in the Recommendations/Instructions in the latest version of PI0564: Wax Coating on Frame Peeling, Metal Shows Corrosion/Rusting.

9. Select a conductive fastener for the repair. Refer to the latest version of Bulletin 10-08-45-001: Information for Electrical Ground Repair - Use New Replacement Fasteners with Conductive Finish.

10. Using a small brush, apply Dielectric Lubricant to both sides of the G400 terminal, install and secure as needed.
11. Perform the corrosion control procedure as outlined in the Recommendations/Instructions in the latest version of PI0564.
