Service Bulletin

Bulletin No.: P11339

Subject: Service Side Detection System Message Displayed on Driver Information Center (DIC)

Models: 2015 Cadillac CTS Sedan (VIN A)
Built Prior to September 8, 2014

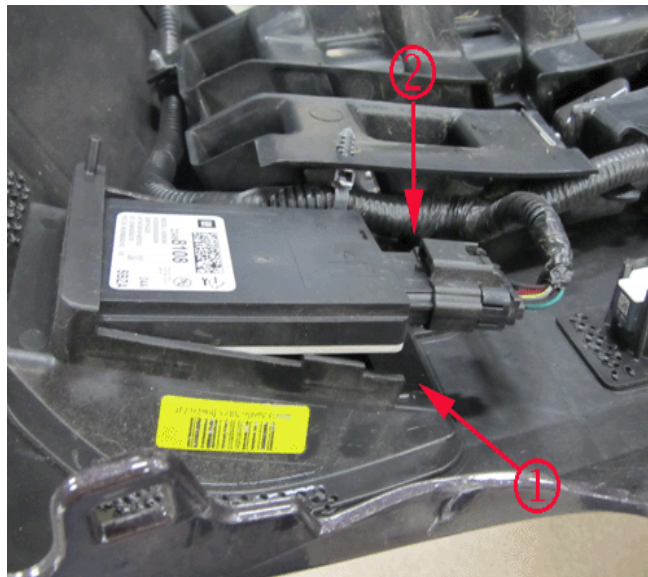
- Identify if the left or right side object sensor module (1) is not retained in the bracket properly and identify if the module's connector (2) is not fully seated.

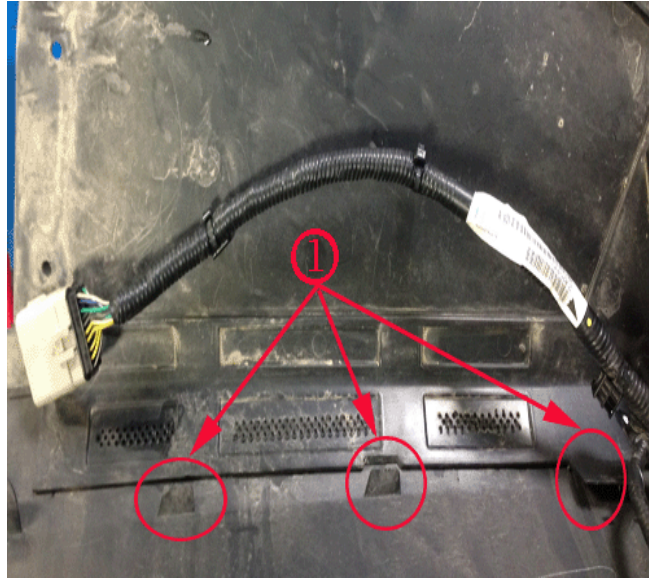
3988678

- Inspect the rear fascia harness retainers (1) for being loose.
2. Secure the side object sensor modules and the fascia harness retainers, if necessary.
