# Service Bulletin

Bulletin No.: PI1341

**Subject:** Cooled Seat Fan Making Tapping Noise When in Use

**Models:** 2014-2015 Chevrolet Impala (VIN 1)  
Equipped with Ventilated Driver and Passenger Front Seats (RPOs KU1, KU3)  
Built Prior to June 20, 2014

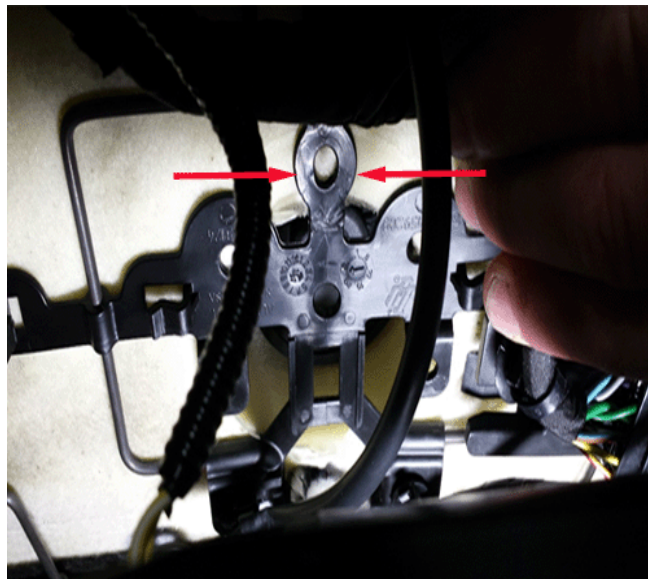
4002473

Some customers may comment on a tapping noise heard when using cooled seats. This condition may be due to the seat cushion heat harness coming in contact with the cooling fan.

Re-route the seat cushion heat harness under the flex mat away from the cooling fan and attach a harness clip to the new location under the seat as shown above.
