Service Bulletin

Bulletin No.: PI1343

Subject: Harsh or Tie-Up Feeling from 6-4 Downshift

Models: 2012 Chevrolet Avalanche, Silverado, Suburban, Tahoe
2012 GMC Sierra, Yukon Models
Equipped with 6L80 Automatic Transmission (RPO MYC)

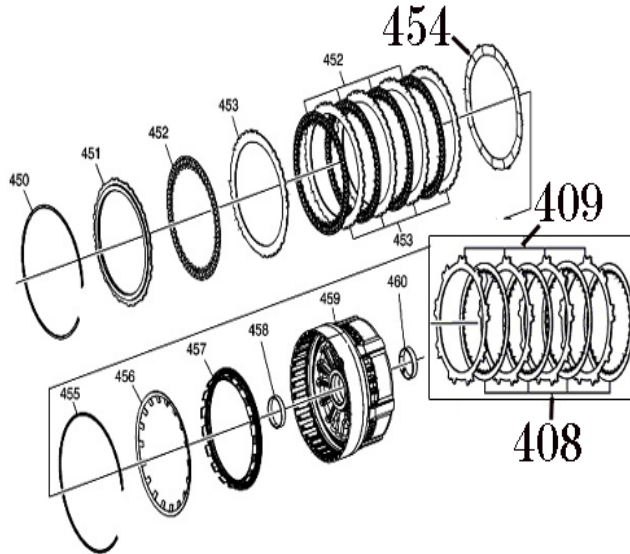
4004575

Some customers may comment on a harsh (detent) 6-4 downshift. The customer may also describe that during a heavy throttle application, a tie-up feeling followed after throttle has been released by a harsh 6-4 downshift.

1. Perform the Reset Transmission Adapts in Service Information (SI) (Document ID #2571000).
2. Road test the vehicle to verify if the condition has been corrected.
3. If the condition has been corrected, replace the 2-6 clutch wave plate (454).

Note: When replacing the 2-6 clutch waved plate, the 1-2-3-4 clutch fiber (408) and steel plates (409) should also be replaced as they are likely to be distressed.
