Service Bulletin

Bulletin No.: PI1349

Subject: Exhaust Rattle Noise at Cold Startup

Models: 2013-2015 Chevrolet Camaro
Equipped with 3.6L Engine (RPO LFX) and
Performance Exhaust System (RPO NPP)

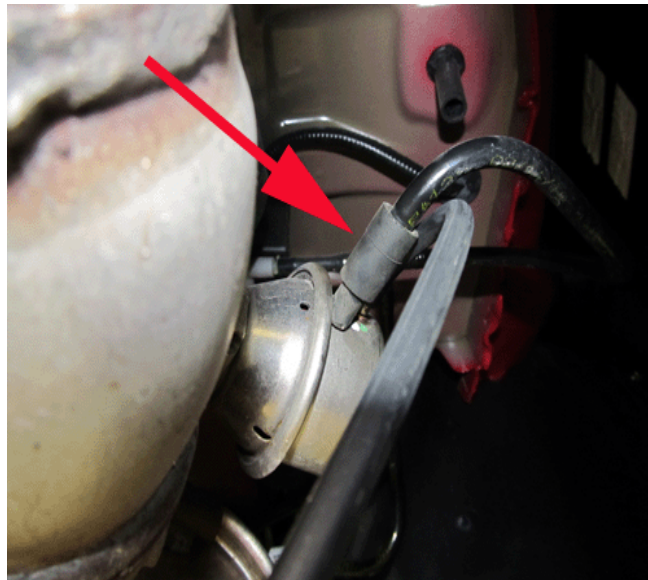
3976649

1. Raise and support the vehicle. Refer to the Lifting and Jacking the Vehicle in SI.
2. Obtain a hand vacuum pump and an appropriate length of hose to attach to the exhaust valve. Place your thumb over the end of the hose and verify the hand pump or hose DOES NOT HAVE a vacuum leak.

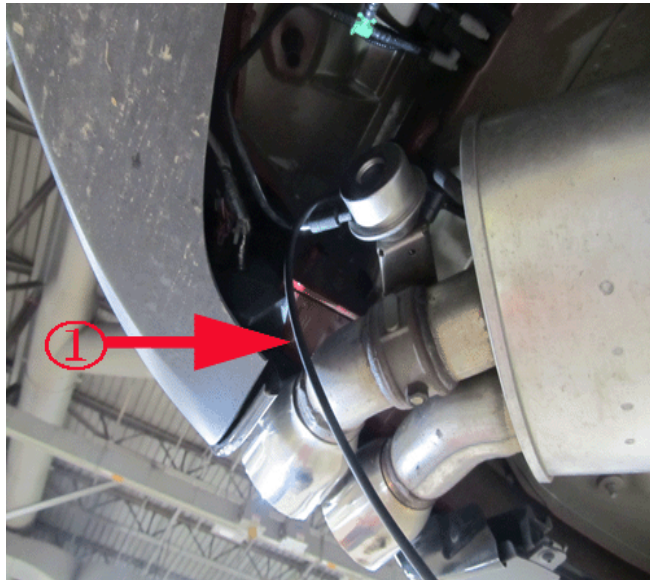
3976656

3. Disconnect the vacuum hose from both valves.

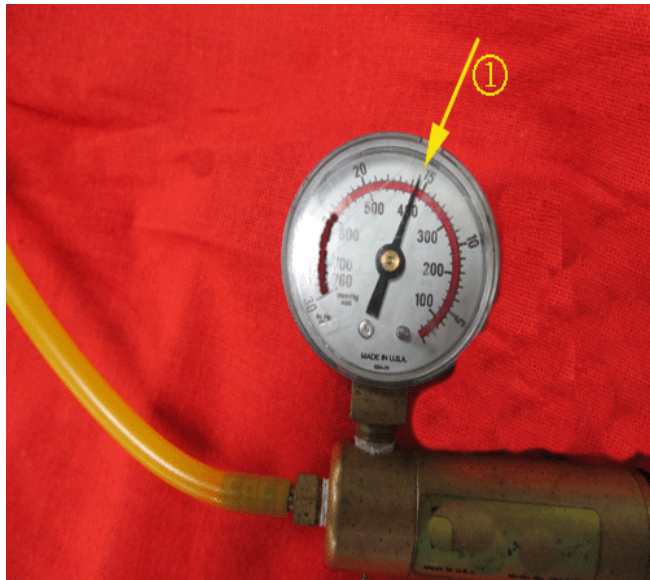
3976764

4. Install the test vacuum pump/hose (1) assembly to one of the exhaust valves.
