# **Service Bulletin**

### Subject: 6.6L Duramax Fuel Injection Pump Part Restriction

Models:2010 through 2015 Chevrolet Express, Silverado2010 through 2015 GMC Savana, SierraEquipped with the 6.6L Duramax Diesel Engine RPO codes LGH and

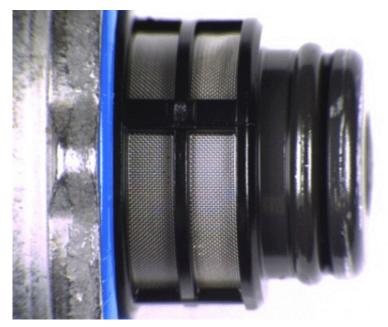
Clean Fuel Pressure Regulator 1 (View A)

If the debris on the Fuel Pressure Regulator compares closest with Group A; more diagnosis is needed. The Fuel Injection Pump is not experiencing the condition described in the latest version of PIP4949.

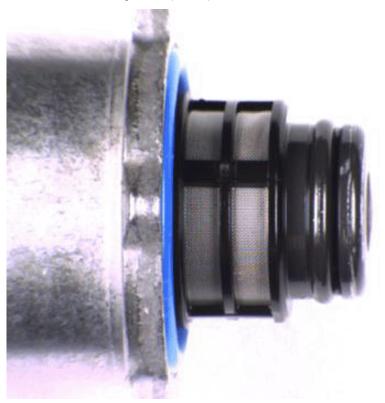
Clean Fuel Pressure Regulator 1 (View B)

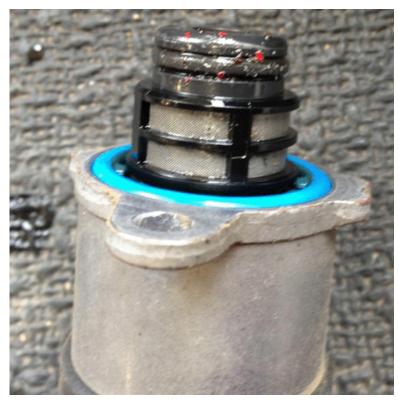
Questionable Fuel Pressure Regulator 1 (View A)

If the debris on the Fuel Pressure Regulator compares closest with Group B; more diagnosis is needed. Remove the Fuel Rail Pressure Sensor and/or Fuel Pressure Regulator 2 (Pressure Relief Valve) for inspection.

- If the same debris is found and the debris is magnetic, the Fuel Injection Pump is experiencing the condition described in the latest version of PIP4949.
  Call PQC to request the Fuel Injection Pump.
- If there is no debris found or non-magnetic debris found, the Fuel Injection Pump is not experiencing the condition described in the latest version of PIP4949.

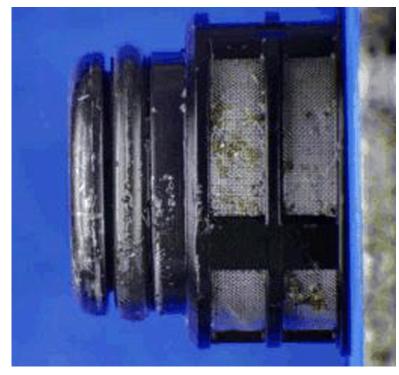
Questionable Fuel Pressure Regulator 1 (View B)

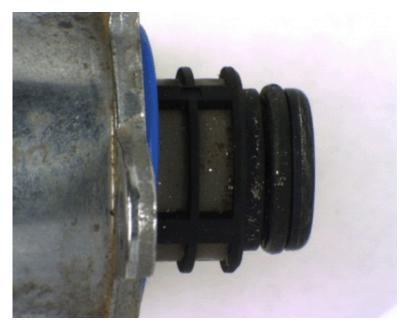
Questionable Fuel Pressure Regulator 1 (View C)

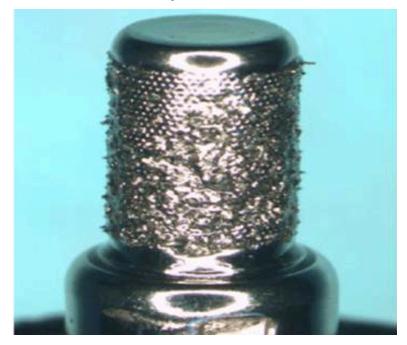
Contaminated Fuel Pressure Regulator 2

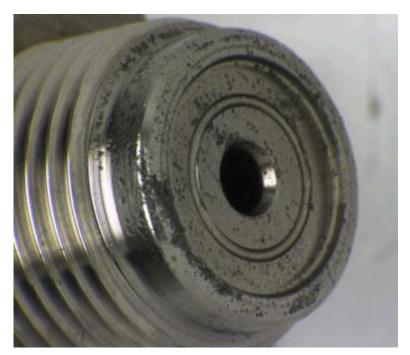
Contaminated Fuel Pressure Sensor

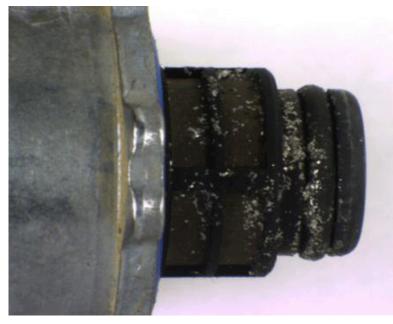
Contaminated Fuel Pressure Regulator 1 (View A)

If the debris on the Fuel Pressure Regulator compares closest with Group C and the debris is magnetic; the Fuel Injection Pump is experiencing the condition described in the latest version of PIP4949. Call the PQC to request the Fuel Injection Pump.

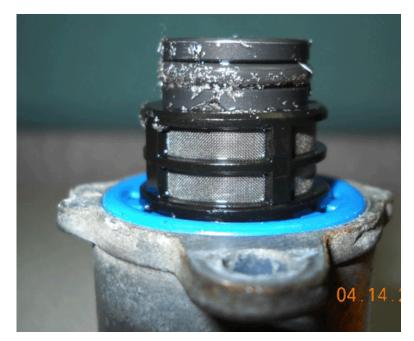
Contaminated Fuel Pressure Regulator 1 (View B)

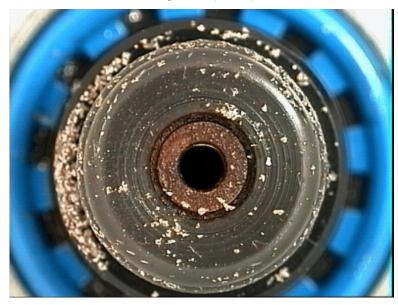
Contaminated Fuel Pressure Regulator 1 (View C)
