# Service Bulletin

## PRELIMINARY INFORMATION

**Subject:** Blower Motor Fan Speed Frozen on Display

**Models:** 2013 Chevrolet Camaro  
Equipped with Either Radio RPO UFU or UHQ

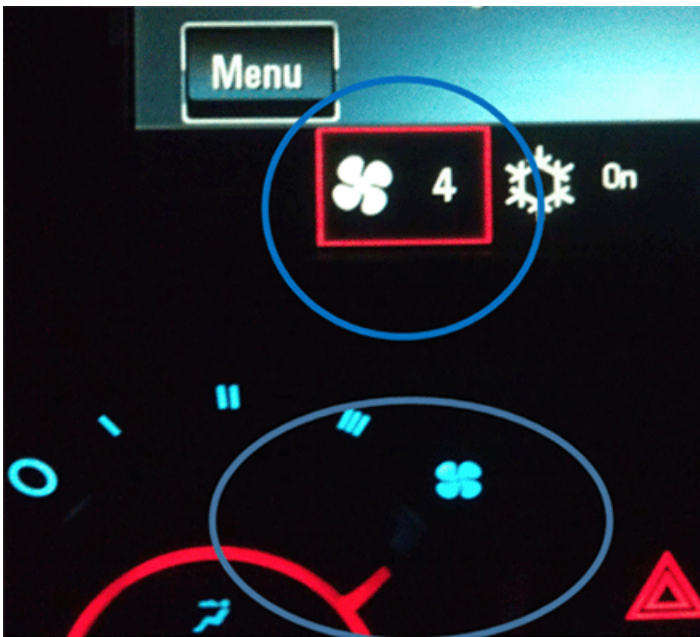
Some customers may comment that the blower motor fan speed display is "frozen" on the radio display. This will be noticed after the vehicle has been started. For example, in the photograph below, notice that the blower motor rotary knob has been set to the "high" position but the indicated blower motor speed above it shows blower speed as level 4. This is shown as an example only. The actual car may freeze on any indicated blower motor speed.

The cause of this specific concern is due to a software mismatch between the Electronic Climate Control Module (ECC) and the radio.

If the customer's vehicle exhibits the concern described above, dealership technicians are to contact the General Motors Technical Assistance Center (TAC) to request the software fix for this issue.

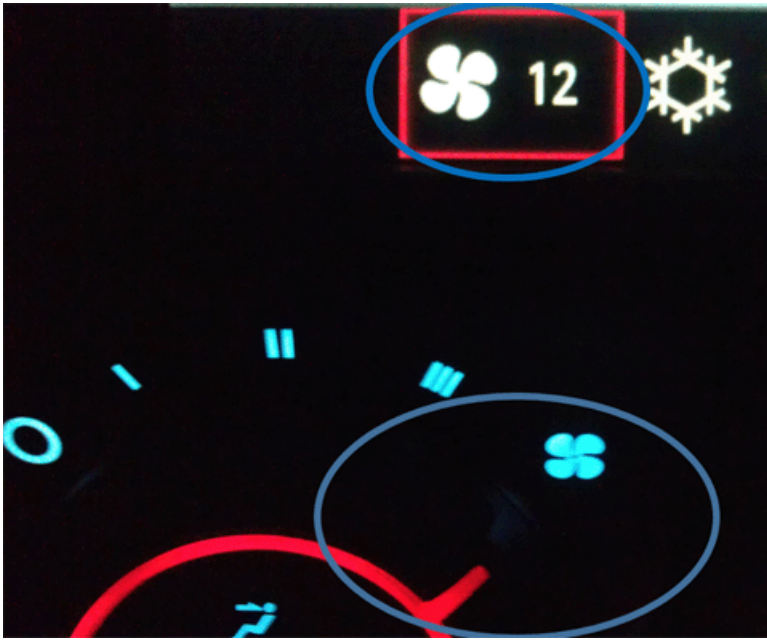
The following photo shows a correctly operating HVAC system. The blower motor rotary knob has been set to the "high" position once again, but the radio display correctly indicates the blower speed as level 12.
