Service Bulletin

Subject: (EREV) Reduced Propulsion with P0C17 P1B03 Or P0C01 (Drive Motor 1 Only)

Models: 2011- 2015 Chevrolet Volt

2014- 2015 Cadillac ELR

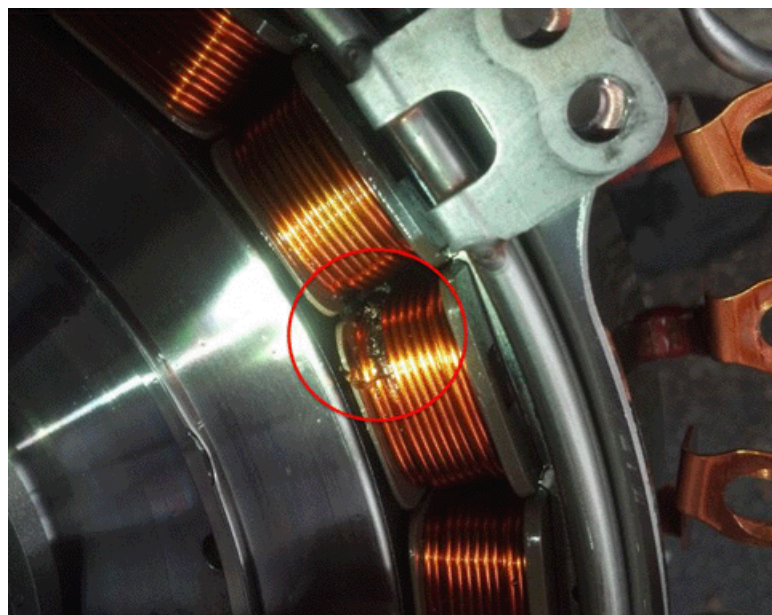
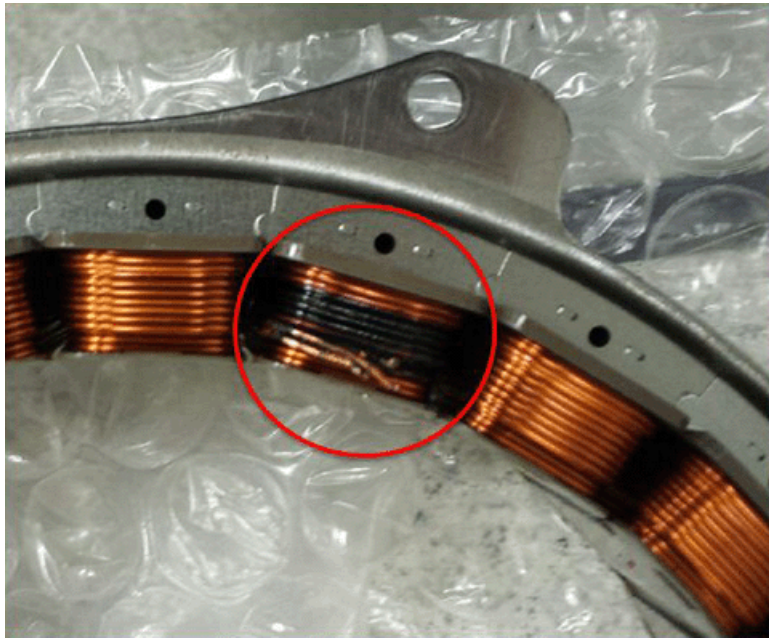
During diagnosis, a technician may find P1B03, P0C01, or P0C4E set in history.

Some customers may comment that the Check Engine Light (CEL) illuminated with an "Engine Unavailable" and "Propulsion Power is Reduced" messages on the DIC. The customer may also comment there is rough operation especially with the engine running. The most common DTC for this condition is P1B03.

Some SI diagnostic procedures may not comprehend the possibility of the Motor 1 Stator as the cause of these DTCs. If one or more of these diagnostics are set, especially on a vehicle with a lifetime fuel economy below 50 mpg and above average annual mileage, inspect the Motor 1 Stator for damage as shown in the pictures below.

If no damage is found, replace all of the following parts: Motor 1 Position Sensor, Transmission Internal Harness, and Motor 1 Stator (damage may be on windings below the top layer). Replacing the Drive Motor Generator Control Module should only be ordered if the condition persists after replacing these parts.
