Service Bulletin

Subject: Integrated Center Stack Display Delaminating Distorted Or Appears Cracked Behind Lens

Models: 2013-2014 Cadillac ATS, SRX, XTS
2014 Cadillac CTS VIN A, ELR
Equipped with Cadillac CUE 8 inch Touch Screen

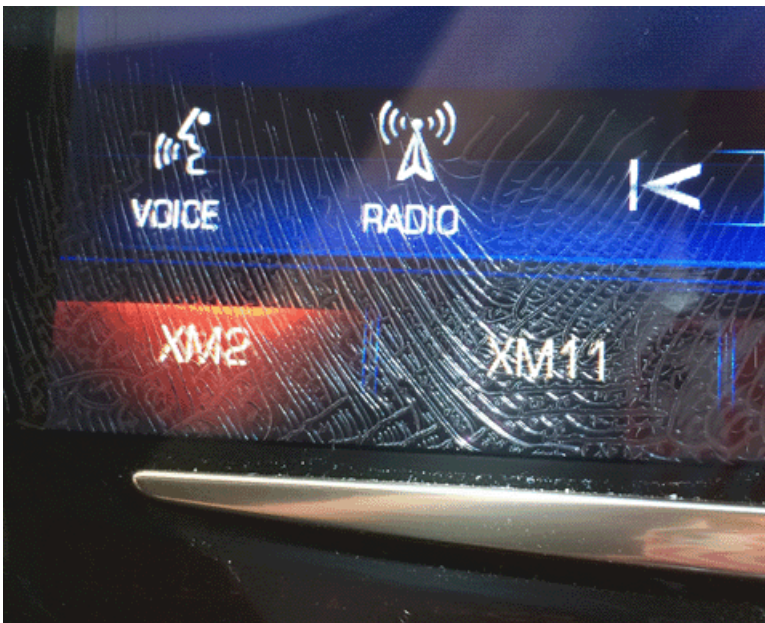
Some customers may report that their radio screen appears bubbled, cracked, or is delaminating.

If this concern is encountered, replace the ICS (Integrated Center Stack) by following the SI replacement procedure.
