BTB 01276 (1412)

## TIGHTEN FUEL CAP Message On or DTC P0455 and/or P0456 is Set

Year	Model	Trim	VIN Range
2013–14	RDX	ALL	ALL
2015	RDX	ALL 2WD	5J8TB3...FL000001 thru 5J8TB3...FL010016
2015	RDX	ALL AWD	5J8TB4...FL000001 thru 5J8TB4...FL017148

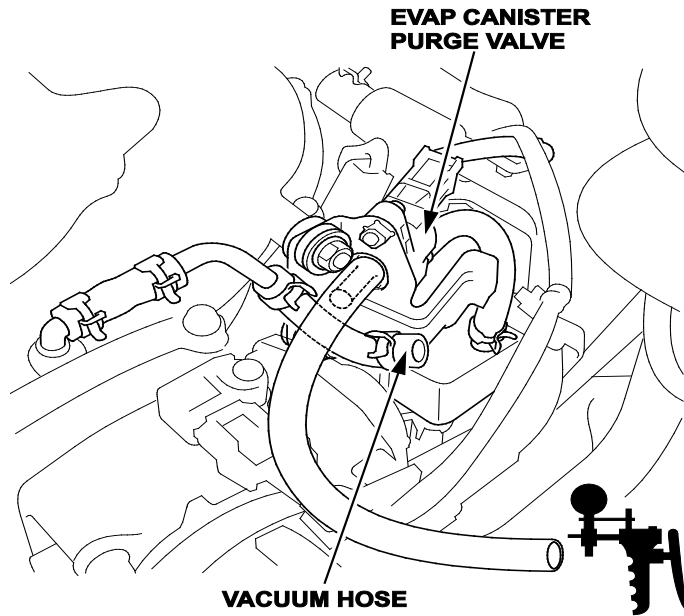
3. Disconnect the vacuum hose from the engine side of the EVAP canister purge valve in the engine compartment, then connect a vacuum pump/gauge to the purge control solenoid valve as shown.
