**Document ID:** IK0800264

**Title:** Erratic rear lighting, water pump and back up alarm in combination

**Applies To:** eStar production

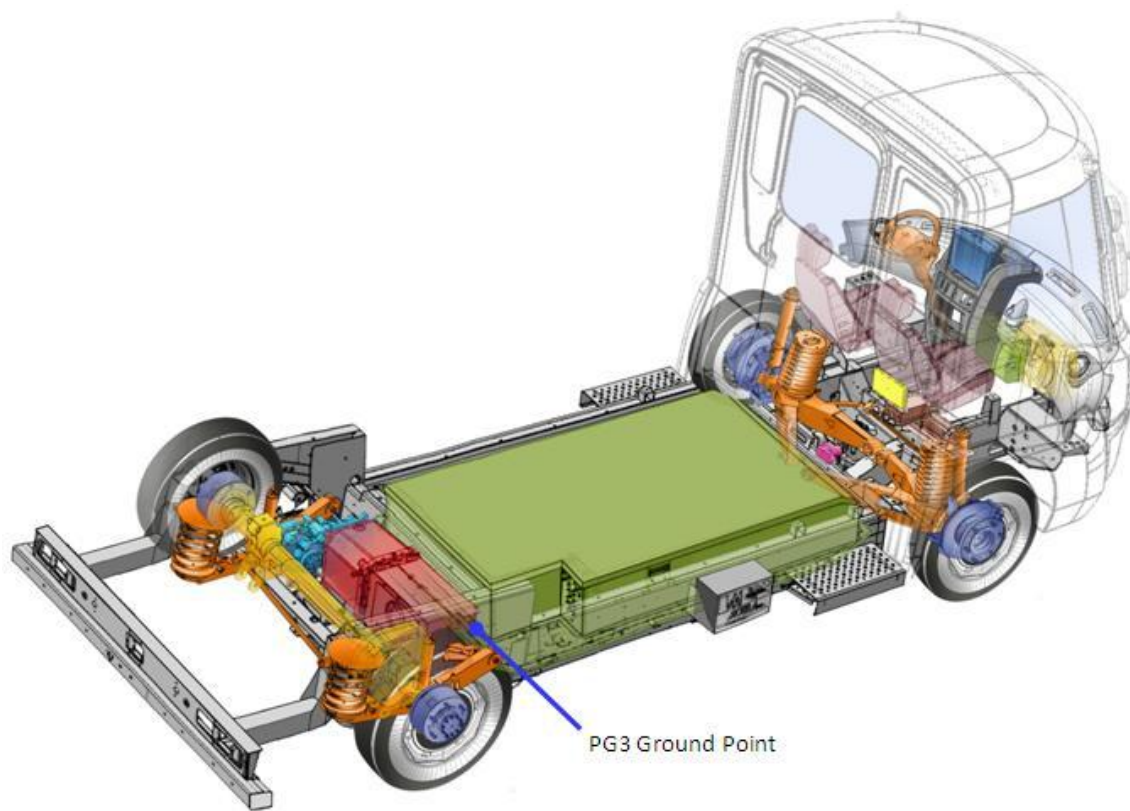
- The turn signal lights come on in place of running lights, turn signals do not indicate properly, the water pump works sporadically, the backup alarm sounds erratically if at all, backup lights do not work. All symptoms present at the same time.

- Locate the PG3 ground point located on the right hand rear of the chassis crossrail in front of the inverter and the high voltage inverter leads. It is best viewed looking upward toward the outer framerail from in front of the inverter. Use a long screwdriver or similar object to test the tightness of the ground by attempting to spin it.

If the ground is loose use the appropriate tools to tighten the nut on the stud. Recheck for correct component operation.
