Document ID: IK0800442
Revision: 1
Created: 7/11/2013
Last Modified: 3/10/2014
Author: Patrick Gotschall

Title: Auxiliary Battery Box - Cover Difficult to Remove

Applies To: Prostar or any vehicle with Feature Code 0008XGG (auxiliary battery box)

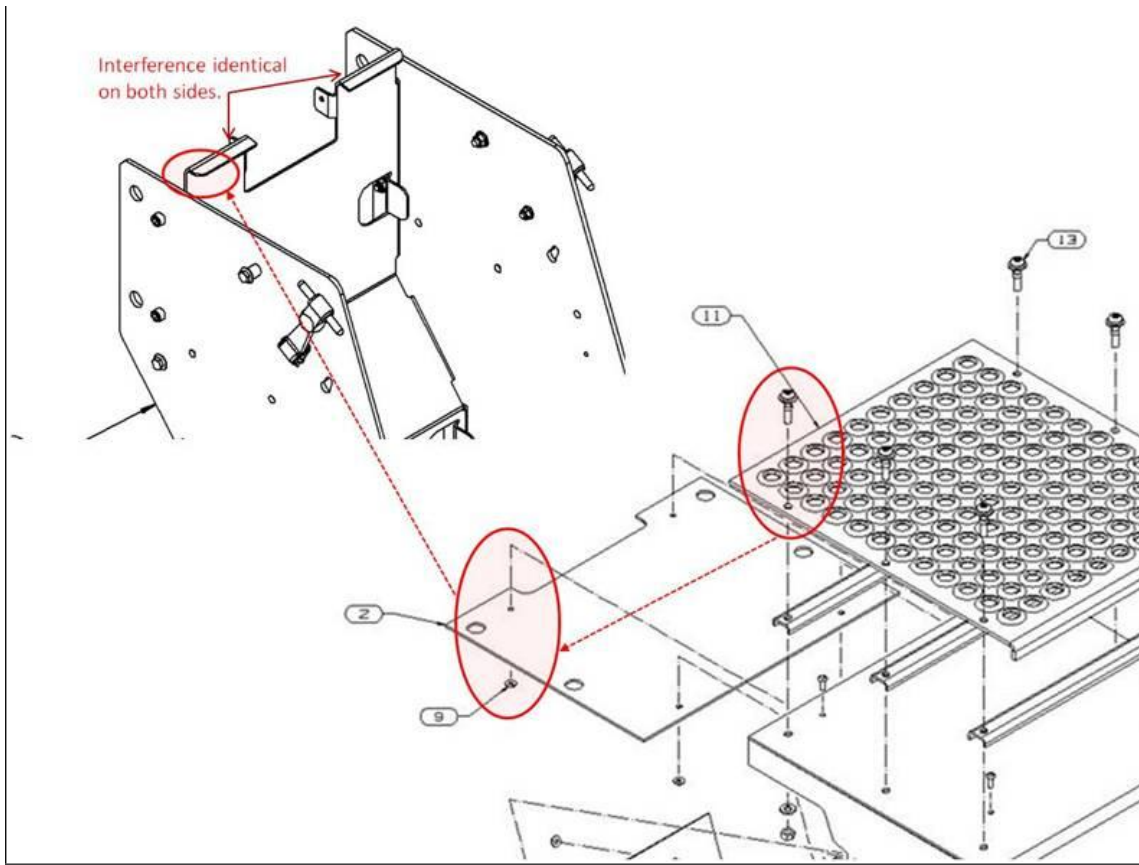
An interference condition can occur between cover bolts or step plate and a flange on the back plate of the battery box. This document describes the condition and remedy of replacing the existing bolt with a shorter bolt to eliminate the interference condition.

Figure 1 - Replace bolts causing the interference

Part #	Description	Qty.
3588153C1	Bolt - M8 x 30	2

Replace 2 - 3804756c1 M8x35mm bolts indicated as item 13 in Figure 1 w/ 2 - 3588153c1 M8x30 bolts.
