| <b>Countries:</b> | CANADA, UNITED STATES, MEXICO | <b>Document ID:</b> | IK0800483 |

**Title: Steering Column Harness Rub**

**Applies To: ProStar® and ProStar®+**

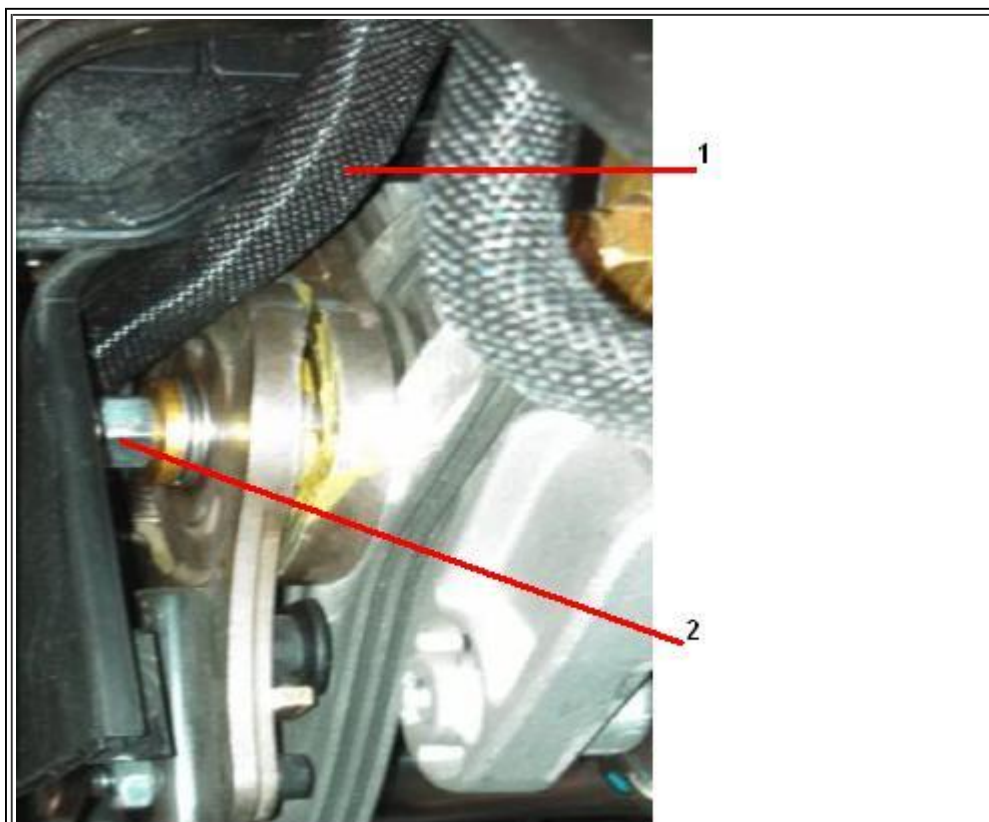
**Figure 1: Harness Routing Inspection Point 1.**

4. Inspect routing of steering column harness (Figure 1, Item 1) at steering column locking mechanism bolt (Figure 1, Item 2).
5. If steering column harness (Figure 1, Item 1), at steering column locking mechanism bolt (Figure 1, Item 2), is located on top of steering column locking mechanism bolt, re-position the

steering column harness so that it is positioned under steering column locking mechanism bolt (as shown below). **Verify that the harness to locking mechanism has minimum of 3/8" clearance.**

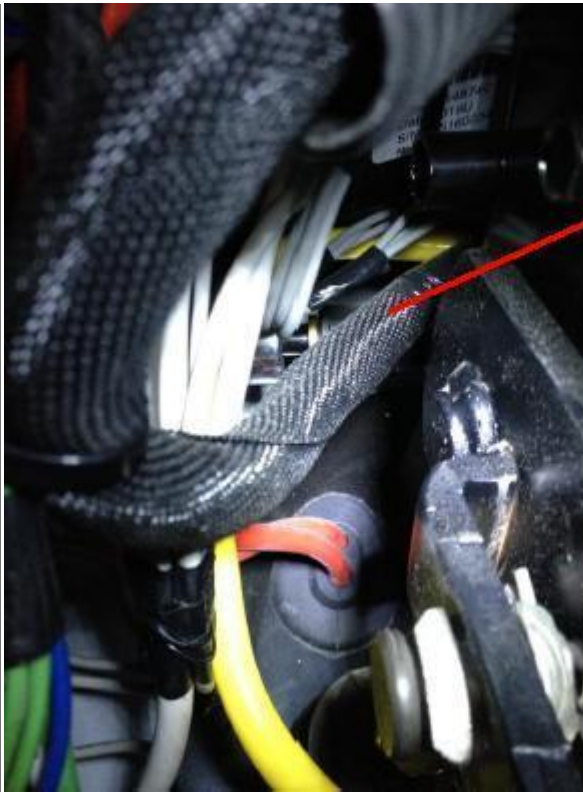
**Figure 3: Harness Routing Inspection Point 2.**

6. If clearance can't be achieved or there is a rub point at the clutch pedal (Figure 3, Item 1) re-position the harness up and to the left (driver side) and secure to the main IP harness. See Figure 4. **NOTE: Ensure tie strap is wrapped around a taped area and not bare wires.**

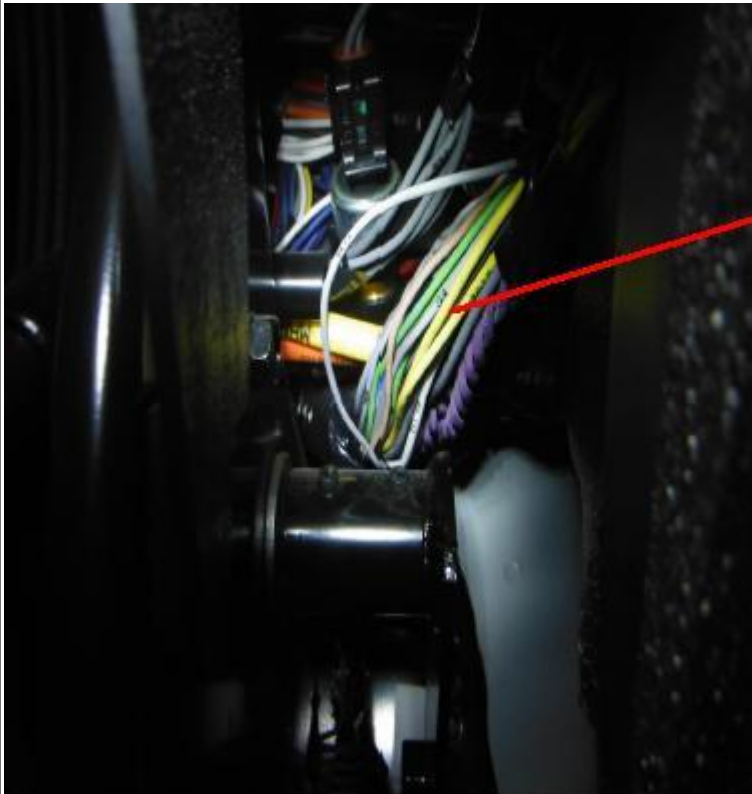
**Figure 5: Harness Routing Inspection Point 3.**

7. Inspect routing of steering column harness (Figure 5, Item 1) on right side of Driver Control Module (DCM) for loose wires.
