Countries: CANADA, UNITED STATES **Document ID:** IK1100031
Availability: ISIS, FleetSIS **Revision:** 5
Major System: CLUTCH **Created:** 10/29/2013
Current Language: English **Last Modified:** 3/27/2014
Other Languages: NONE **Author:** Matthew Boyer
Viewed: 2154

Title: Hard to Crank Condition on ProStar, LoneStar, and TranStar Vehicles

Applies To: ProStar, LoneStar, and TranStar Vehicles with Hydraulic Clutch Linkage and Solo Clutch

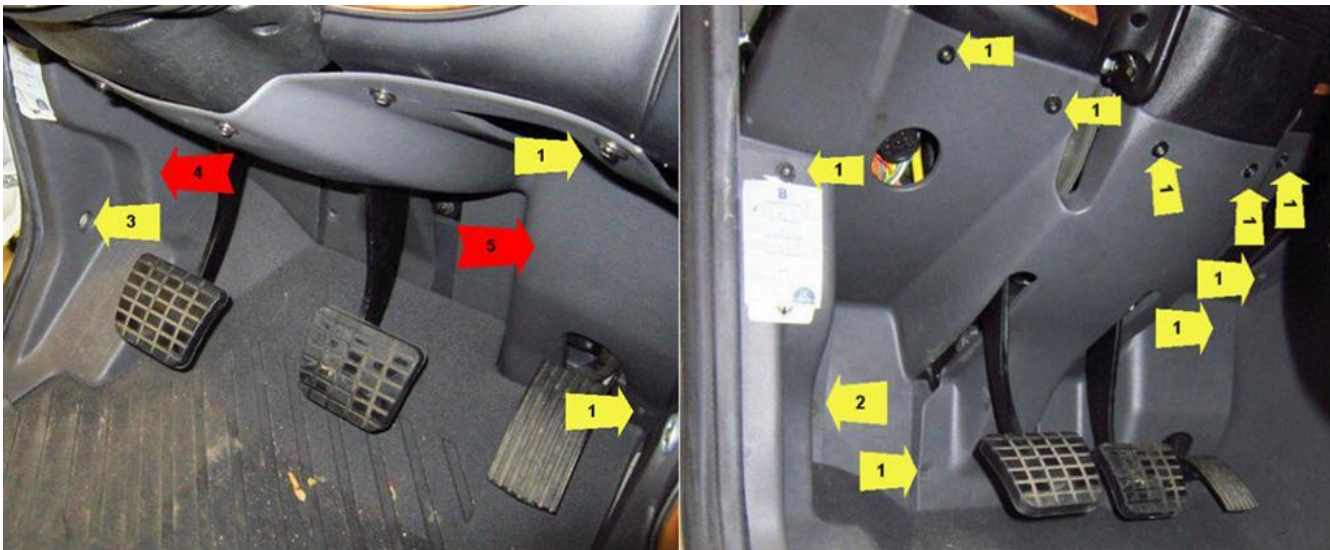
Remove the 11 self tapping pan head black screws, the 1 M6x35mm bolt, and the M8x45mm Bolt holding the 2 driver control module modesty panels. Once the fasteners are removed, the panels (4 and 5) can be removed and set aside.

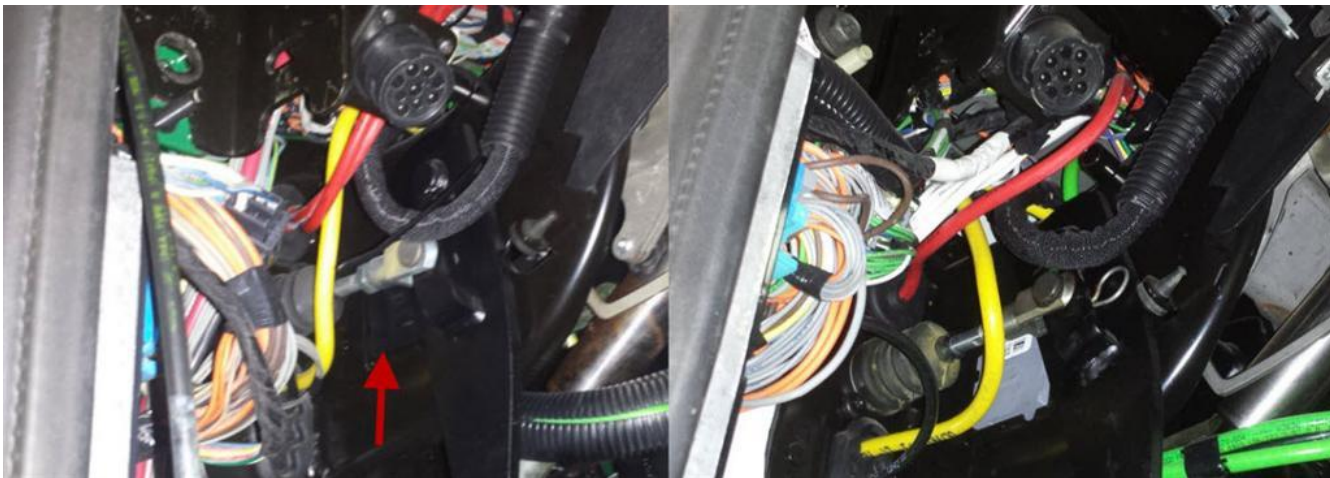
Inspect the color of the clutch switch. If the switch body is black, it will need to be replaced with switch part number 2512776C91.

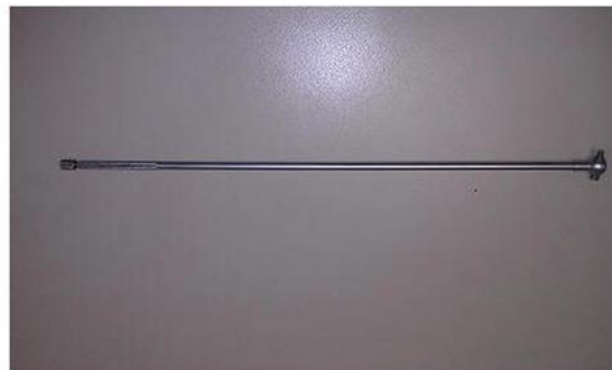
Remove the clutch inspection cover, and measure the bearing to brake position. Inserting a bar that is about 0.500" is NOT an acceptable procedure for checking the clutch bearing to brake measurement.

- Preferred Procedure- Use a telescoping gage or inside caliper capable of a 0.400" - 0.600" range, and insert it between the clutch bearing and the clutch brake aligned with the center of the brake and the center of the bearing. Then measure the gage using a micrometer or a dial/digital caliper.
- Alternate Procedure- Use a feeler gage set (shim stack), and stack the correct number and size feeler gages to allow the feeler gage stack to fit snugly between the clutch bearing and brake. Then measure the feeler gage stack using a micrometer or a dial/digital caliper.

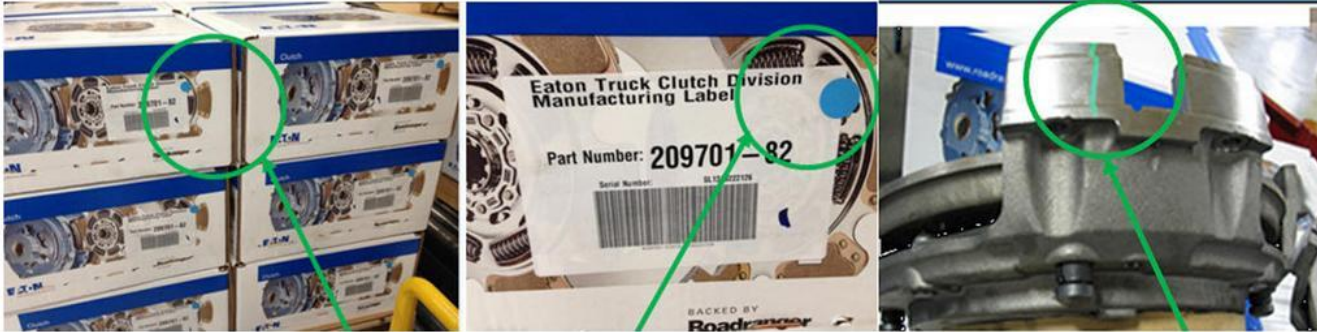
Please see the below photos to identify a replacement clutch. These are clutches that must be used on all ProStar and LoneStar vehicles. Vehicles with a mechanical linkage system can continue to use clutches without the markings. All these clutches are certified to have a bearing gap above 0.530" at the Eaton end of line tester. These clutches can be identified by the following witness marks:

- A blue dot placed on the corner of the part label on the box
- A green line on the pressure plate ear nearest the cam tab

To ensure you receive a clutch that has a blue dot, please order a clutch from the PDC. When ordering the clutch, notate on the order " Please ensure the label on the clutch box has a blue dot on it, per IK1100031"
