**Document ID:** IK1200739  
**Revision:** 11  
**Created:** 3/16/2012  
**Last Modified:** 3/21/2014  
**Author:** Daniel Modesto

**Title:** EGR Valve Diagnostics

**Applies To:** 2010 Emissions MaxxForce 11 & 13 Liter Engines

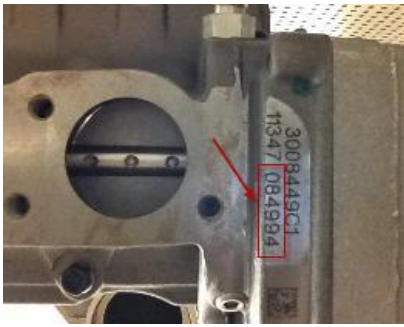
Serial Number Identification Process shown below:

The generation of the valve can be identified by the serial number ( the 6 digit code highlighted in the red box in the picture above) if it starts with 1 it is considered to be an old valve (On 2010 Emissions MF11/13 only. NOT SCR equipped vehicles). If the serial number starts with a 2 it is a newer generation valve.

**Note :** If it starts with a 0 and has part number 5010697R1 stamped on it the EGR Valve is a New Generation. If it starts with a 0 and has part number 3008449C1 as illustrated above then it is an Old Generation EGR Valve.

| Diagnostic Steps (Table 1) | YES | NO |
|---|---|---|
| 2. Verify Generation of EGR Valve : Is it an Old Generation EGR Valve? (See Serial Number Identification process Below) | Replace the EGR Valve | Continue to Step 3 |

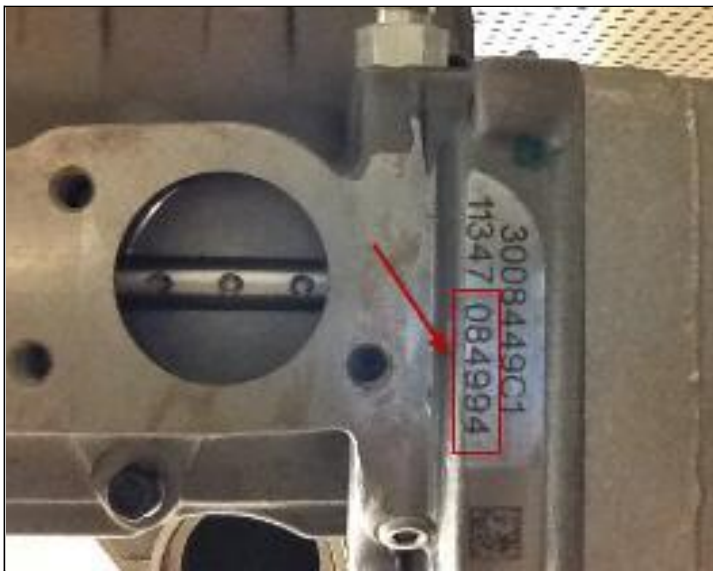
- **Requirement :** Include the Serial Number of the failed and new EGR Valve in the subsequent warranty claim "CCC" and the "Failed Serial #" fields (See Photo Below).
- **Requirement :** Be sure the replacement EGR Valve Serial # starts with a 2 (Serial Number location shown below).
