**Document ID:** IK1200753  
**Revision:** 8  
**Created:** 4/19/2012  
**Last Modified:** 3/4/2014  
**Author:** Jaime Ochoa

## Title: Hydrocarbon Injector & Housing Cleaning Procedure (AFI Plugging)

**Applies To:** EPA 2010 MaxxForce DT, 9, 10, 11, 13, 15

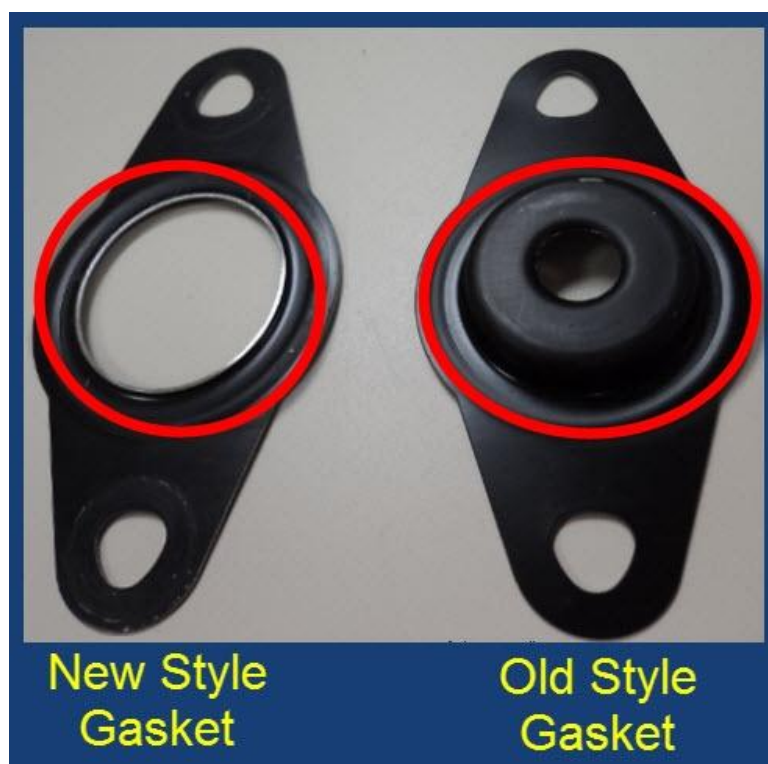
**Figure 1 - Gasket Changes**

The old gasket (p/n **3005521C1**) has been reworked and replaced with p/n **3018016C1**. The new style gasket will have the raised center portion of the gasket removed (Figure 1).

Replace the below gasket and bolts when servicing the HC Injector [aftertreatment fuel injector (AFI) and doser injector].

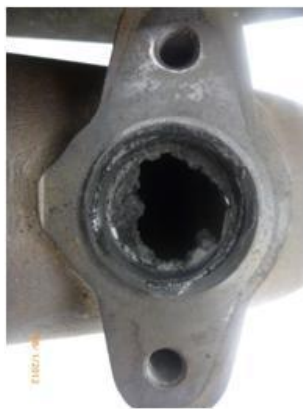
**Figure 2 – Partially plugged AFI port**

Below are photos of a partially plugged port (fig 1), a completely plugged doser (fig 2) and a clear port (fig 3).

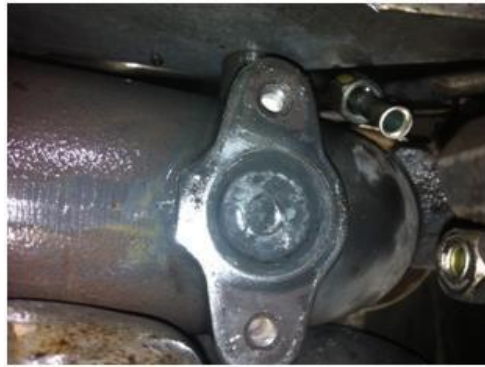
**Figure 3 – Fully plugged AFI port**

A plugged HC injector port will result in improper or frequent aftertreatment regenerations (regens). If the AFI port is plugged, use this procedure and Navistar's Engine Diagnostic Manual (Found on the **Service Portal>Publications>Master Service Information**) for additional reference.
