| <b>Countries:</b> | RUSSIA, AUSTRALIA, CANADA,<br>UNITED STATES, PUERTO RICO, NEW<br>ZEALAND | <b>Document ID:</b> | IK1201040 |

**Title: AFI Fuel Supply Line Rubbing SPN 3556 FMI 7 Codes After Dealer Service**

**Applies To: EPA 2010 IBB MF 11/13/15L**

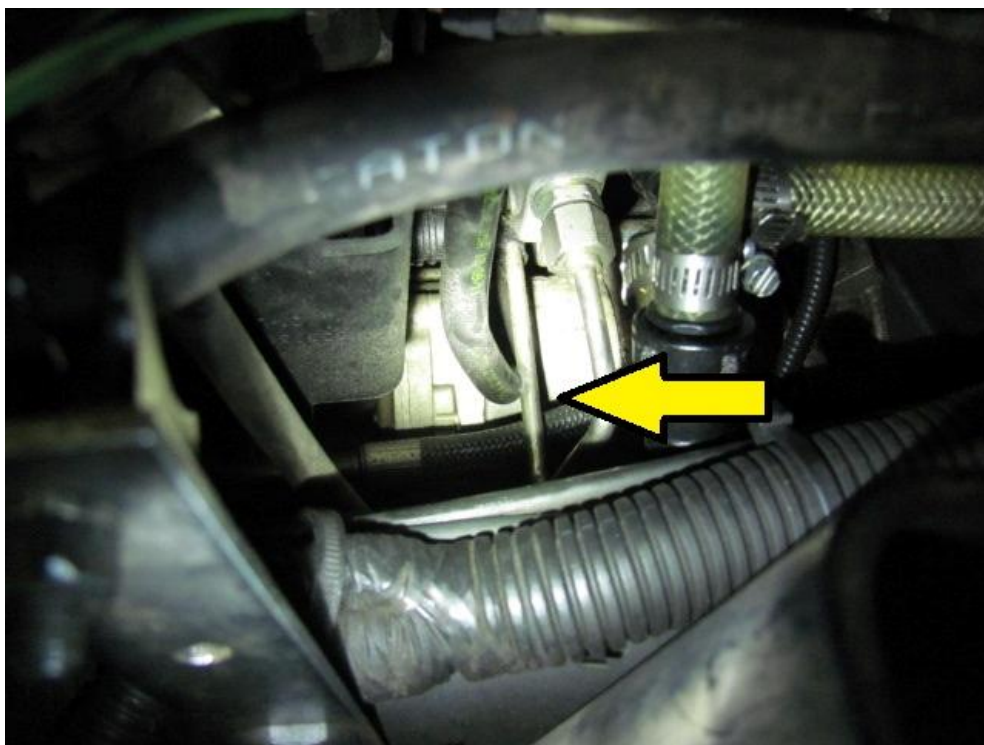
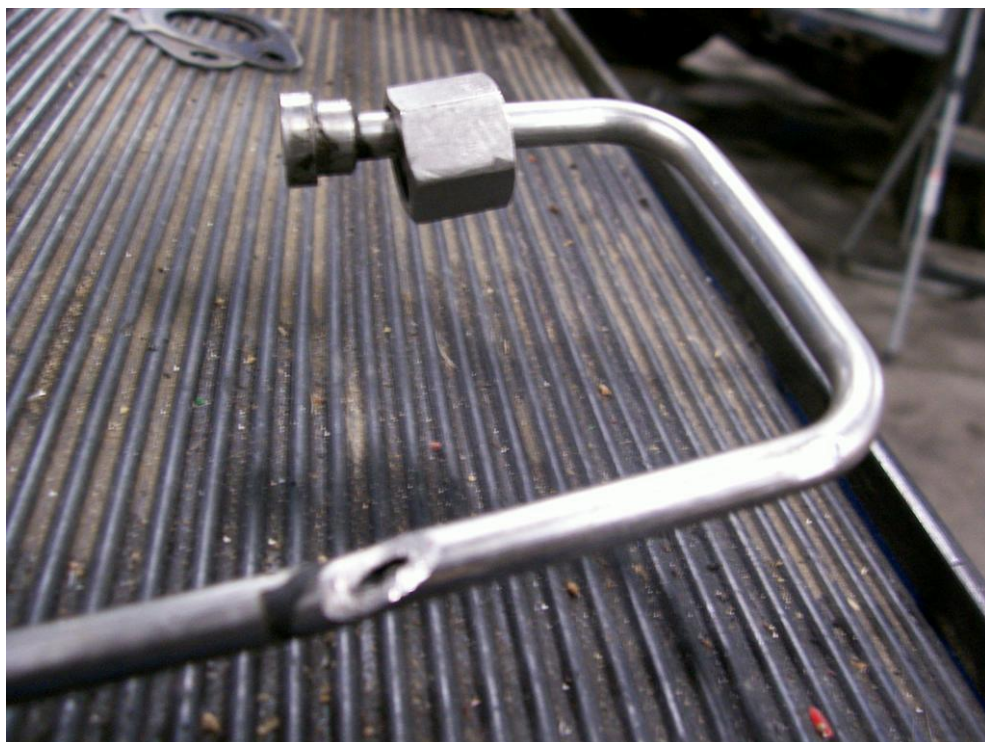
If the fuel lines are not routed correctly the AFI Fuel Supply line can rub through from the fuel system return line and cause regen issues or an inability to perform regens. Due to the ECM sensing a pressure issue in the line it will stop sending fuel to the AFI from the DSI so you will not see a fuel leak in the area. What you will see is a regen issue and aftertreatment temperatures not reaching the correct temp and eventually the ecm will abort the OBFCT.

See how the fuel system return line is rubbing into the afi supply line.

Need to inspect and verify that the afi supply line is secured to the AFI bracket with the P-Clip and that the line separator clip is installed on the return and afi line. Also, be sure the DSI supply line is not rubbing anything. See pic below.

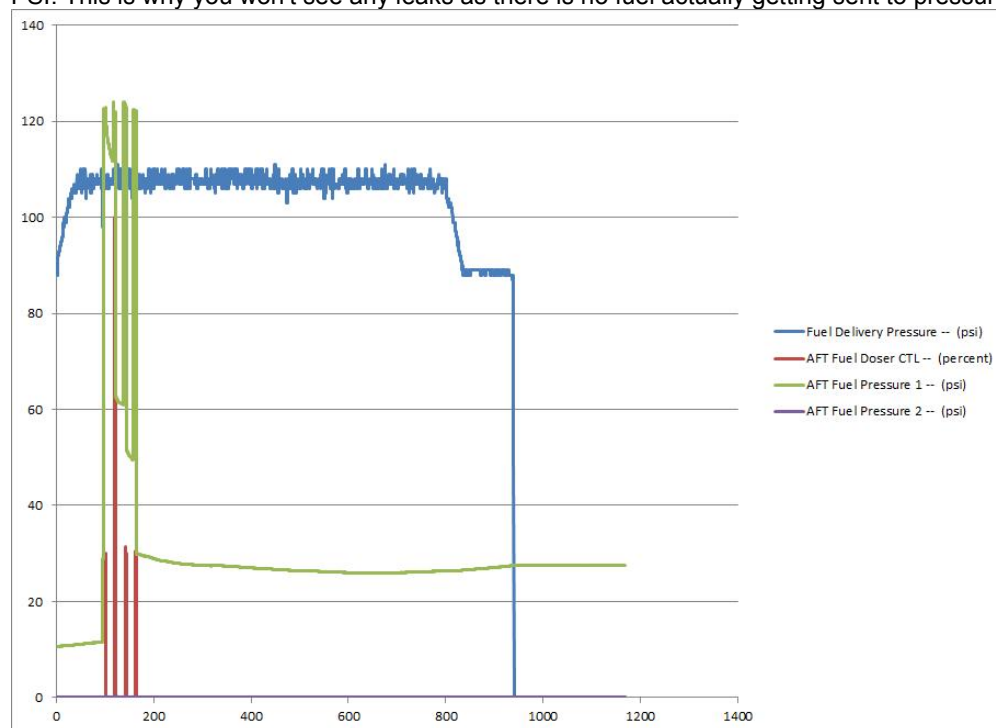
### Example of a bad OBFCT with a hole in the AFI Fuel Supply Line

Notice AFT Fuel Doser CTL actuated 3 times to purge the air then went to 0 and AFT Fuel Pressure 2 never climbed off 0 PSI. This is why you won't see any leaks as there is no fuel actually getting sent to pressurize the line.

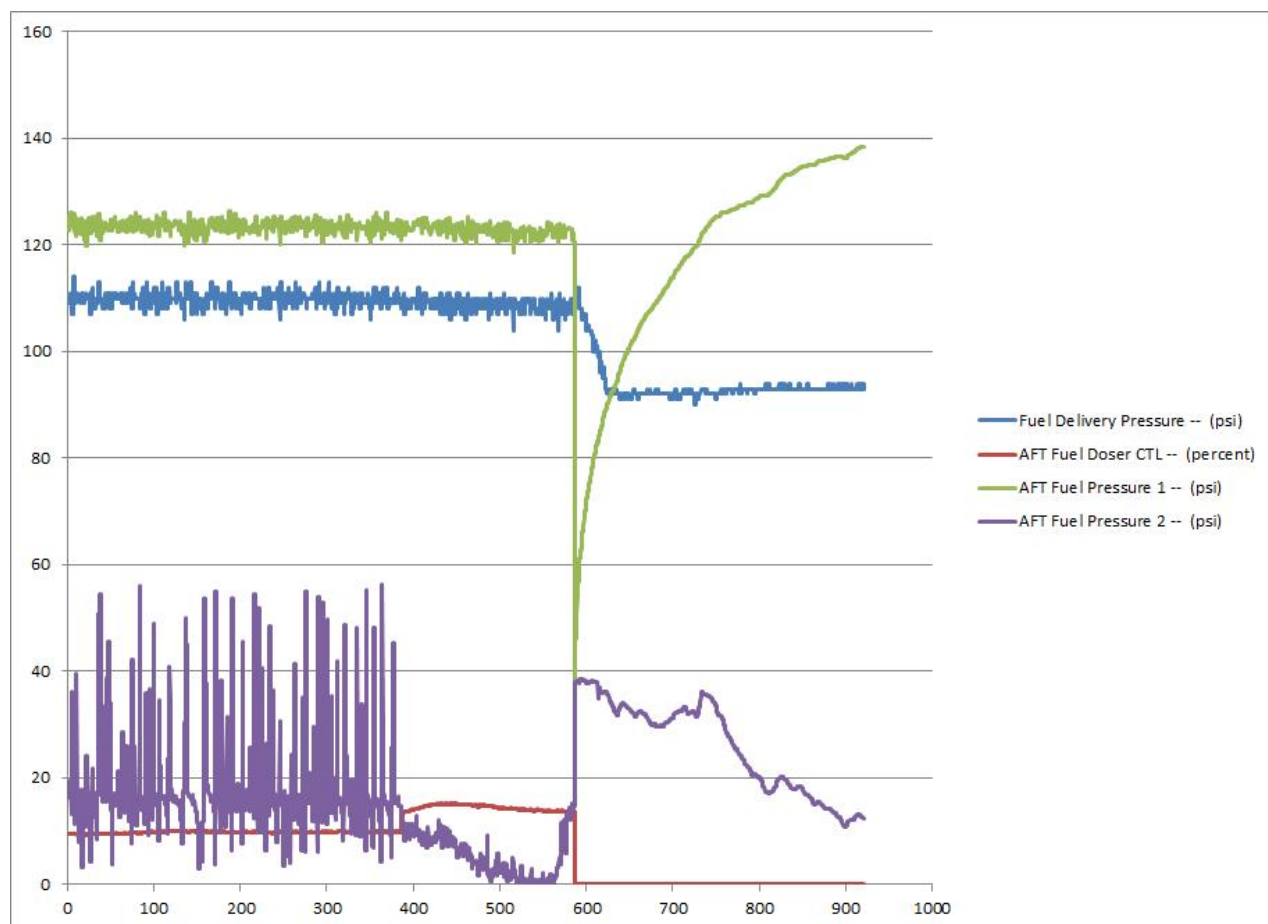
Example of a good OBFCT after the AFI Fuel Supply Line was repaired

Notice the AFT Fuel Doser CTL actuated and stayed active and AFT Fuel Pressure 2 is working properly now.
