**Document ID:** IK1201075  
**Revision:** 1  
**Created:** 2/11/2014  
**Last Modified:** 3/12/2014  
**Author:** Steven Bell

**Title: 2010-2013 IBB Intake Throttle Valve Causing Regen Issues**
**Applies To: 2010-2013 IBB Maxxforce 11/13/15L Engines**

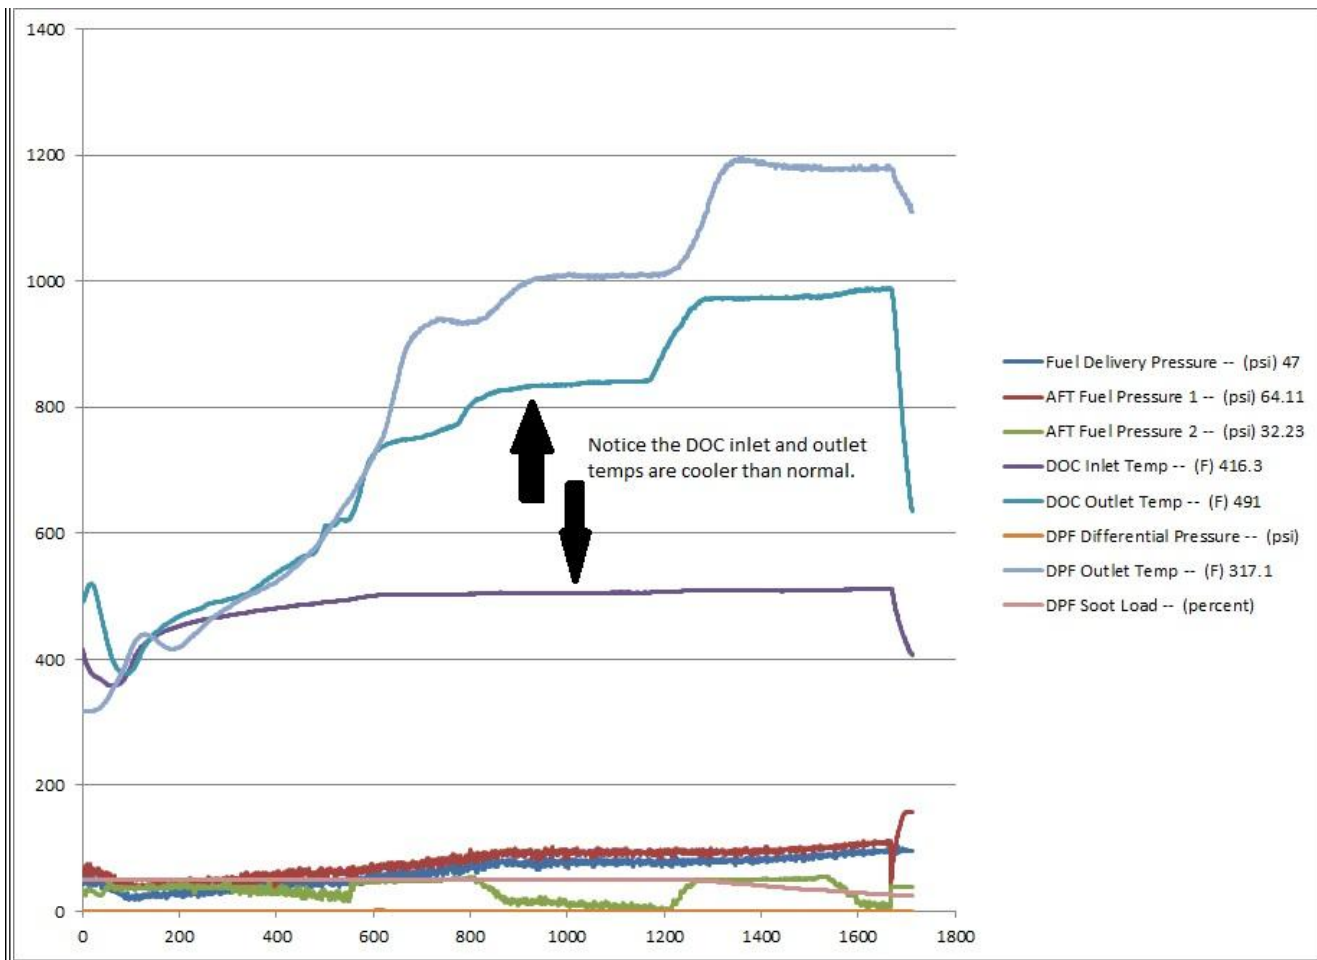
**Figure #1: OBFCT with a Bad ETV**

Item 1: Notice the DOC inlet and outlet temps are cooler than a normal regen should be. DOC inlet should be in the 600-700 degree F range. This is due to the ITV not working properly to produce enough heat in the exhaust system.

Item 2: Notice the length of time it takes for the temps to start rising

Replace the ITV and rerun the OBFCT to verify the repair

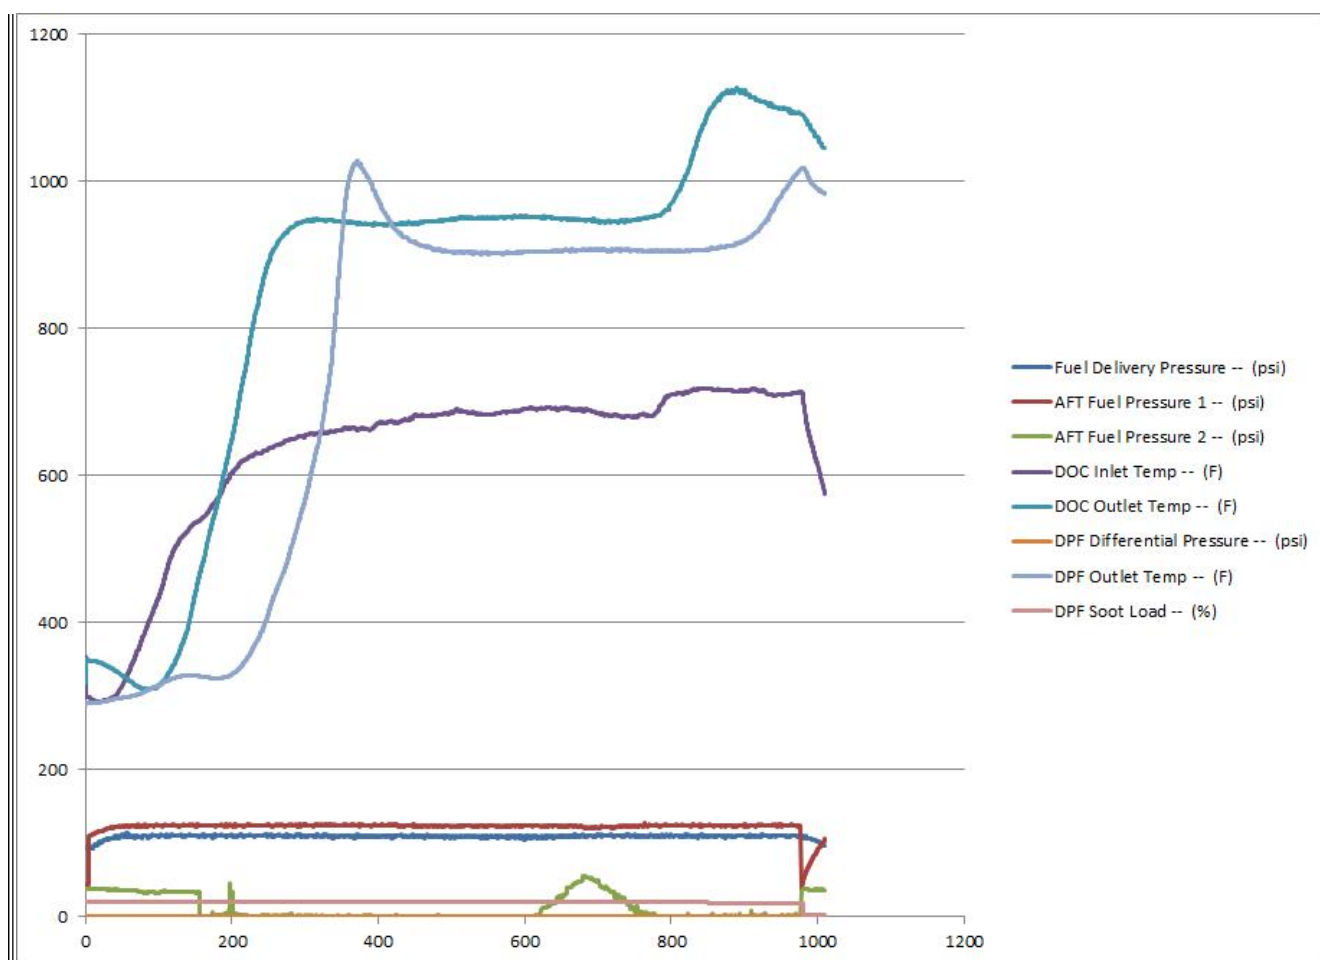
**Figure #2: Good Regen**

Item 1: Notice the temps rise much quicker than the bad regen shows

Item 2: DOC Inlet temp is in a good range
