Countries:	CANADA, UNITED STATES, PUERTO RICO	Document ID:	IK1600008
Availability:	ISIS	Revision:	3
Major System:	CAB / SLEEPER / HOOD	Created:	5/16/2007
Current Language:	English	Last Modified:	3/12/2014
Other Languages:	Français , Español ,	Author:	Patrick Gotschall
Viewed:	199

Title: Bottom Bunk Rattle on ProStar

Applies To: ProStar built before 12-11-07

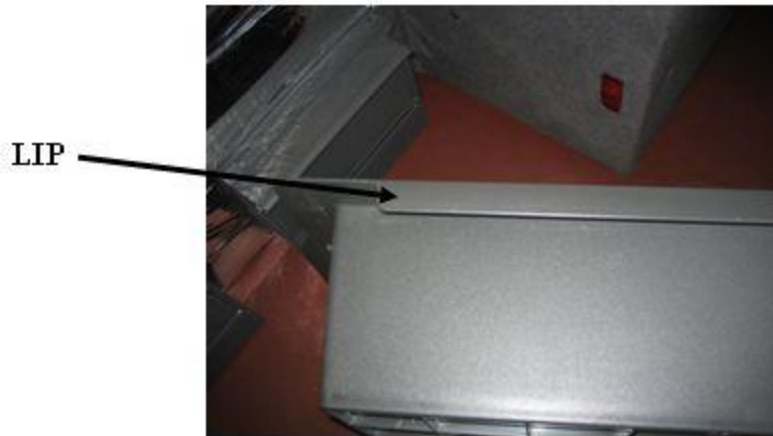
In case of lower bunk rattle on ProStar , follow the following Steps:

1. Move under bunk tray so the rear lip is in front of bulkhead.
