<b>Countries:</b>	CANADA, UNITED STATES, PUERTO RICO	<b>Document ID:</b>	IK1600018
<b>Availability:</b>	ISIS	<b>Revision:</b>	3
<b>Major System:</b>	CAB / SLEEPER / HOOD	<b>Created:</b>	4/20/2007
<b>Current Language:</b>	English	<b>Last Modified:</b>	3/12/2014
<b>Other Languages:</b>	<a href="#">Français</a> , <a href="#">Español</a> ,	<b>Author:</b>	Patrick Gotschall
<b>Viewed:</b>	311

**Title: Door Hinge Hard to Open on 5000's and 9000's**

**Applies To: All 5000 models built prior to 6/2/06, 9000 models (CAP) built prior to 5/24/06 and (EAP) built prior to 6/19/06**

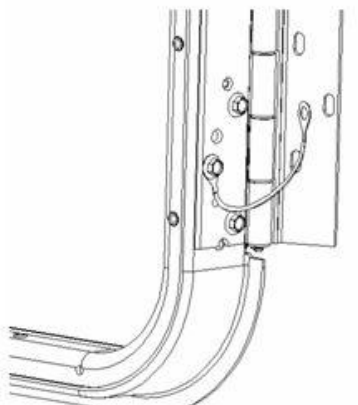
The presence of brass bushings accelerated corrosion within the hinges.

**Brass bushings in prior design provided conductivity for grounding of the CB antenna. The ground strap provides this functionality with the elimination of the brass bushings.**

- 3513636C4 Hinge, Door SD W/Nylon Bushing
- 3803792C1 Strap, Door Hinge Ground

Replace hinge with new part number, ensuring that the ground strap is installed as shown.
