**Countries:** CANADA, UNITED STATES, PUERTO RICO  
**Document ID:** IK1600062  
**Availability:** ISIS  
**Revision:** 2  
**Major System:** CAB / SLEEPER / HOOD  
**Created:** 10/16/2007  
**Current Language:** English  
**Last Modified:** 3/12/2014  
**Other Languages:** [Français](#), [Español](#),  
**Author:** Patrick Gotschall  
**Viewed:** 152

**Title:** ProStar Push-in Trim Fasteners Popping out or Missing

**Applies To:** ProStar

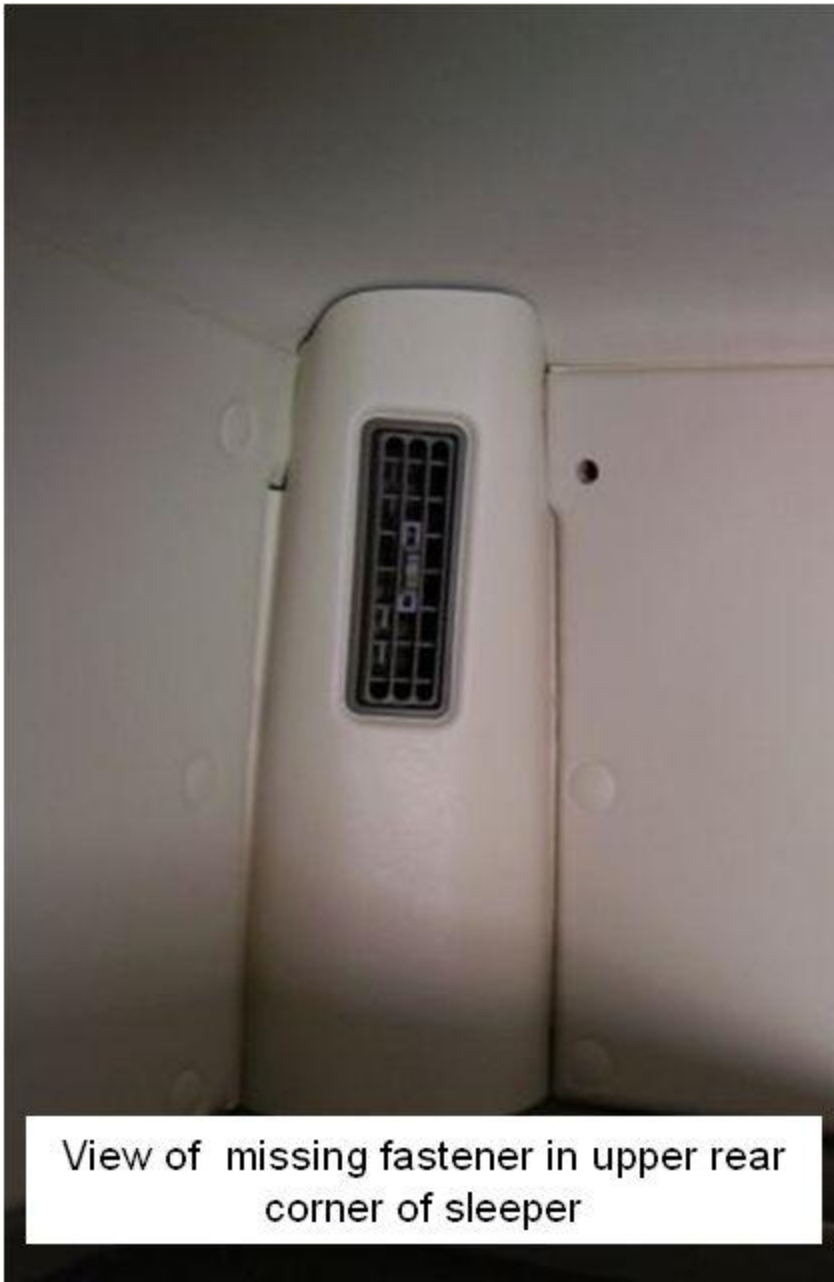
Push-in fasteners pop out or missing from rear trim panel.

Replace with longer push-in fastener, part number 3674238C1. Pre-grained parts are available and acceptable to use if parts are not available in PDC. Contact Hector for Pre-grained parts if this occurs. New fastener can be used in other locations but length may need to be modified.
