**Countries:** CANADA, UNITED STATES, PUERTO RICO  
**Document ID:** IK1600066  
**Availability:** ISIS  
**Revision:** 2  
**Major System:** CAB / SLEEPER / HOOD  
**Created:** 10/16/2007  
**Current Language:** English  
**Last Modified:** 3/12/2014  
**Other Languages:** [Français](#), [Español](#),  
**Author:** Patrick Gotschall  
**Viewed:** 143

**Title:** ProStar Drawer Rattle

**Applies To:** ProStar

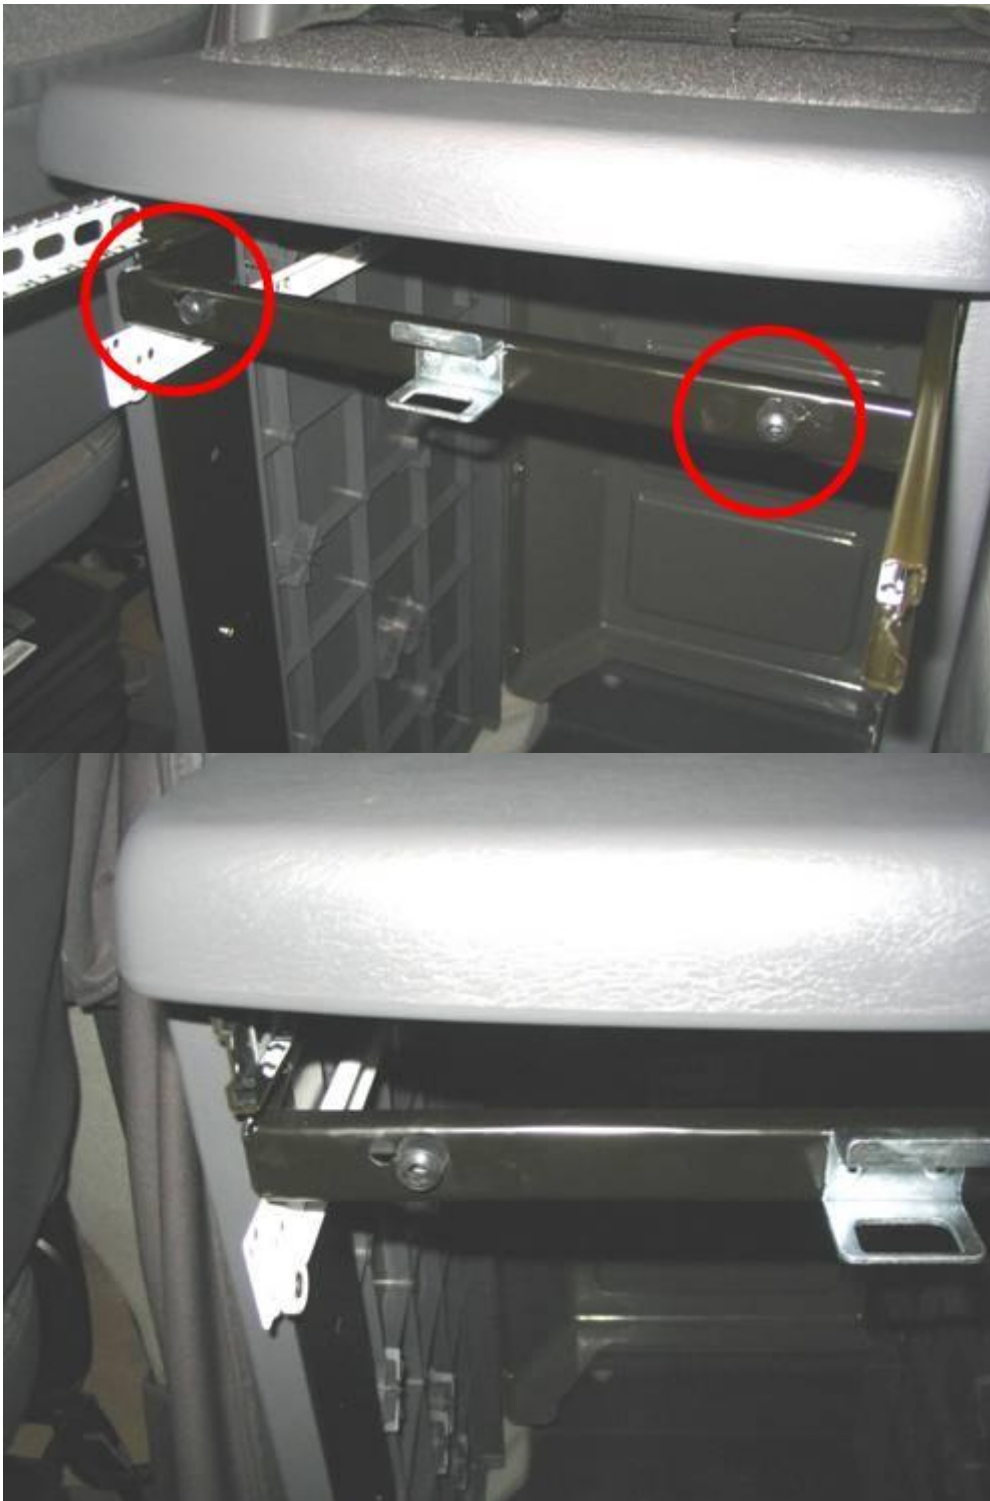
Drawer rattle.

- Remove current rubber bumpers located on crossover bar.
- Drill (2) 6.5 (.26in) mm holes, 20 mm (.79 in) inward from existing holes.
- Install (2) new rubber bumpers (3822105c1).
- Production fix is estimated to be ready by December 1. Contact Hector if Parts are not available.
