| <b>Countries:</b> | CANADA, UNITED STATES, PUERTO RICO | <b>Document ID:</b> | IK1600067 |

**Title: ProStar Work Surface Rattle**

**Applies To: ProStar**

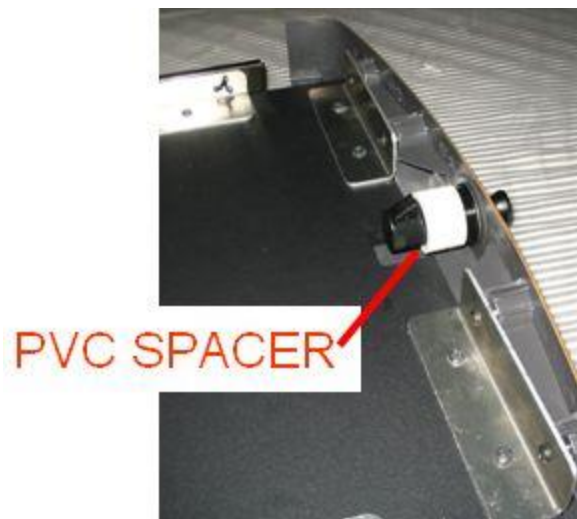
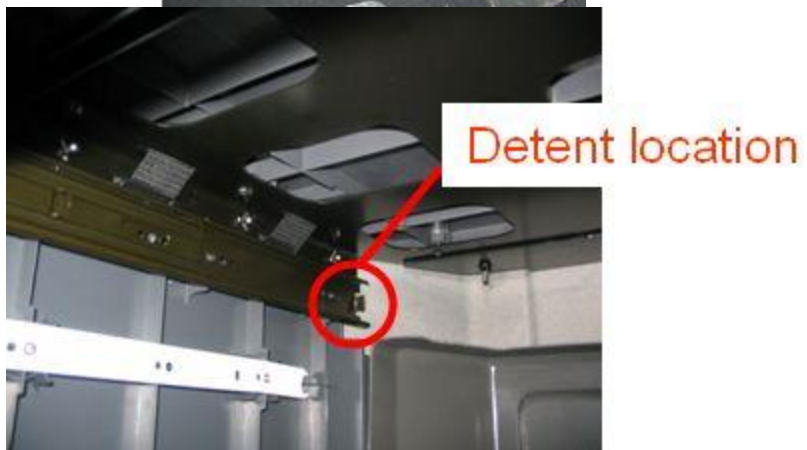
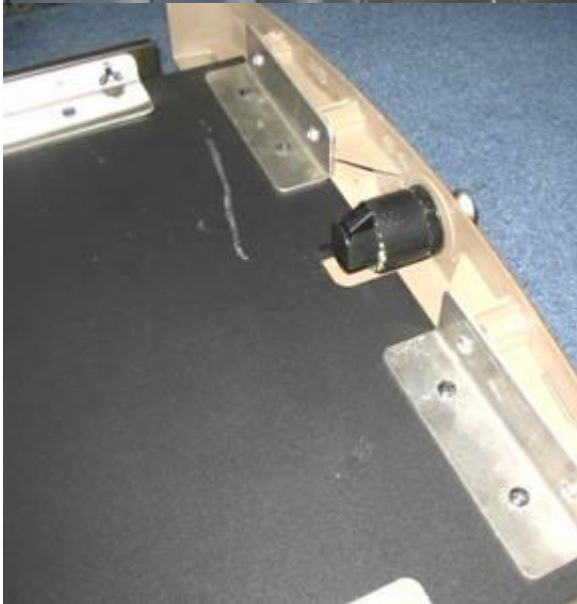
## Work surface rattle.

- Remove small drawer located below work surface.
- Pull work surface fully open.
- If PVC spacer is not present, remove rubber detents located at the rear of work surface slides (Use x-mas tree removal tool if available). If PVC spacer is present remove PVC spacer located on latch.
- Cut a piece of silicone rubber hose (part number 2643493R1) to a length of 22mm (.87in) and install rubber spacer on latch.
