Countries: AUSTRALIA, BRAZIL, CANADA, UNITED STATES, PUERTO RICO, SOUTH AFRICA
Document ID: IK1600068
Availability: ISIS
Revision: 2
Major System: CAB / SLEEPER / HOOD
Created: 10/16/2007
Current Language: English
Last Modified: 3/12/2014
Other Languages: [Français](#), [Español](#),
Author: Patrick Gotschall
Viewed: 159

Title: 2007 Engine Cover Appears to be Scuffed on 7500, 7600, 7700 and 8600

Applies To: 7500, 7600, 7700 and 8600

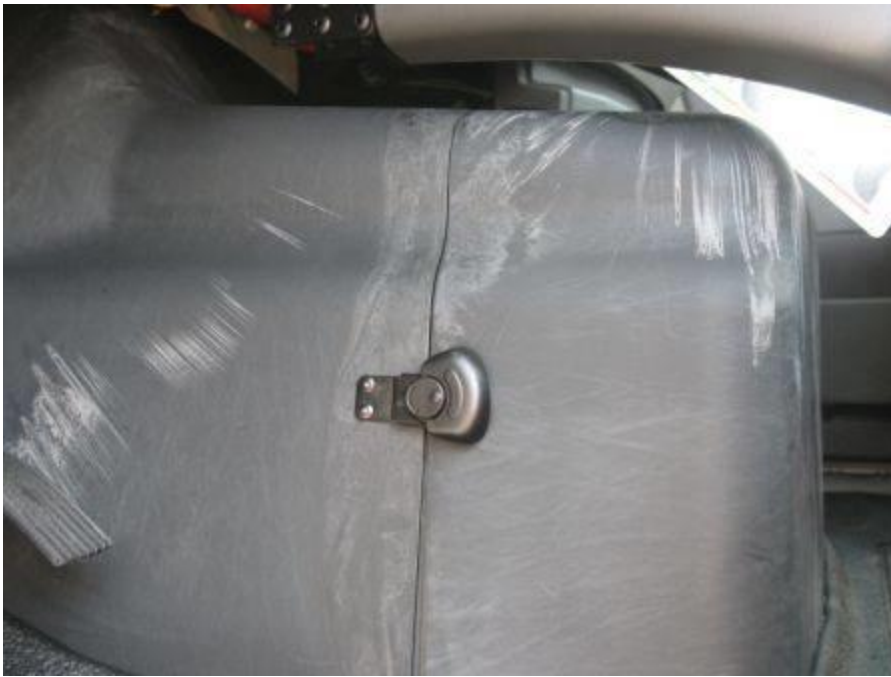
2007 engine cover appears to be scuffed.

Cover with premium Blanket p/n 3587524C1.
Engineering validating long term production fix.
