**December 9, 2014**

ATB 00317 (1412)

## Excessive Vibration Between 30 and 65 MPH

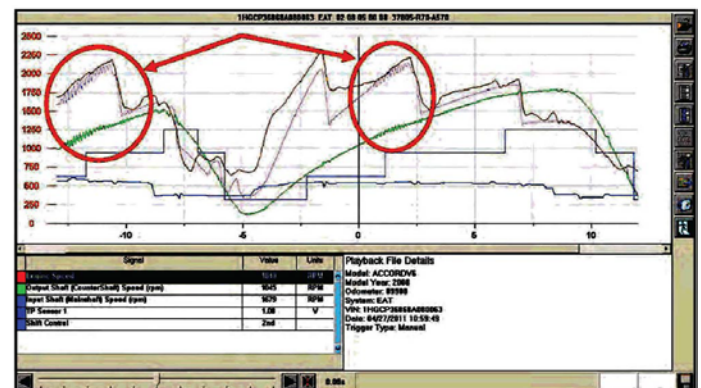
#### POSSIBLE TORQUE CONVERTER ISSUES

- The customer indicated the vibration occurred under braking or hard acceleration.
- The engine is not in valve pause when the vibration occurs.
- The snapshots 1 and 2 indicate fluctuations in the main shaft but the engine speed is steady – review the job aid *Torque Converter Clutch Shudder and Vibration*.

Refer to the Job Aid.

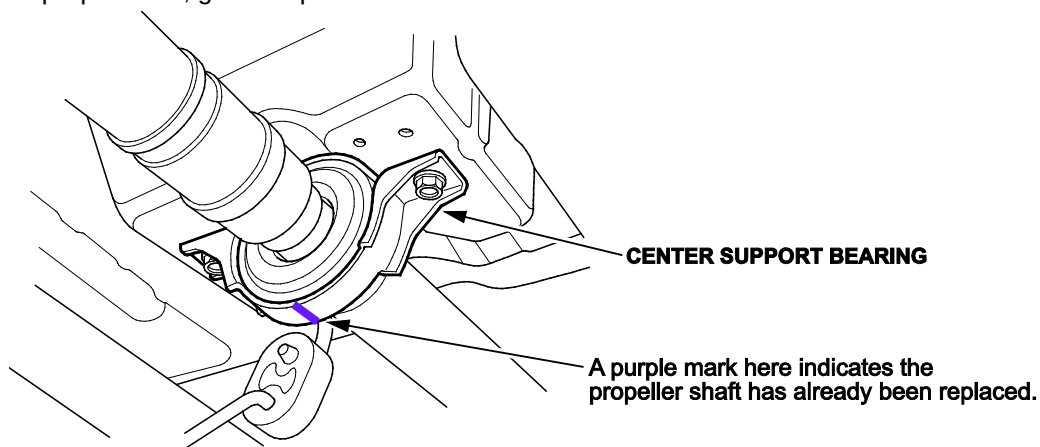
1. Raise and support the vehicle.
2. Check that the propeller shaft has not already been replaced. Check if there is a purple mark on the center support bearing as shown below.
  - If there is a purple mark on the center support bearing, the propeller shaft has already been replaced with a new part. Do not replace the propeller shaft again. If there is still a vibration, this bulletin does not apply. Continue with normal troubleshooting.
  - If there is no purple mark, go to step 3.
