## SERVICE ALERT

### 15MY COE TRUCK – DEF NOZZLE AND SIDE FUEL TANK INSPECTION

| Bulletin No.: | SA-14-021 |

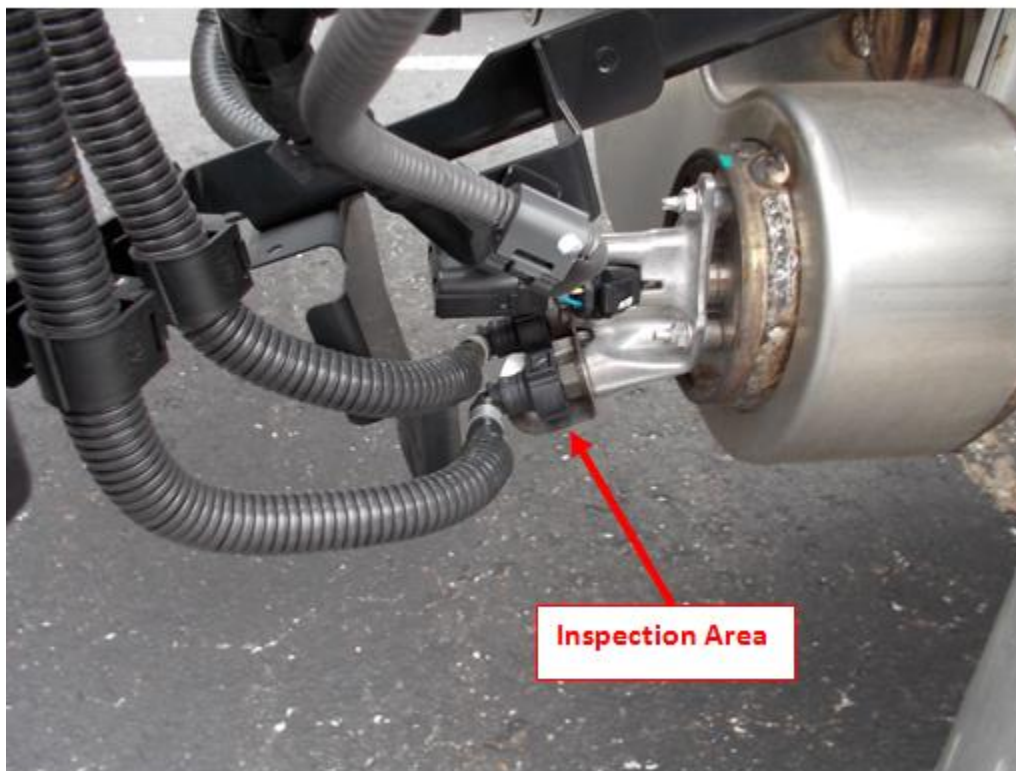
1. Inspect the DEF injector area for coolant leakage, nozzle connectors, lines, and shield for potential damage and repair if necessary. Also, check the coolant level in the radiator and overflow bottle to be sure there is no coolant loss.

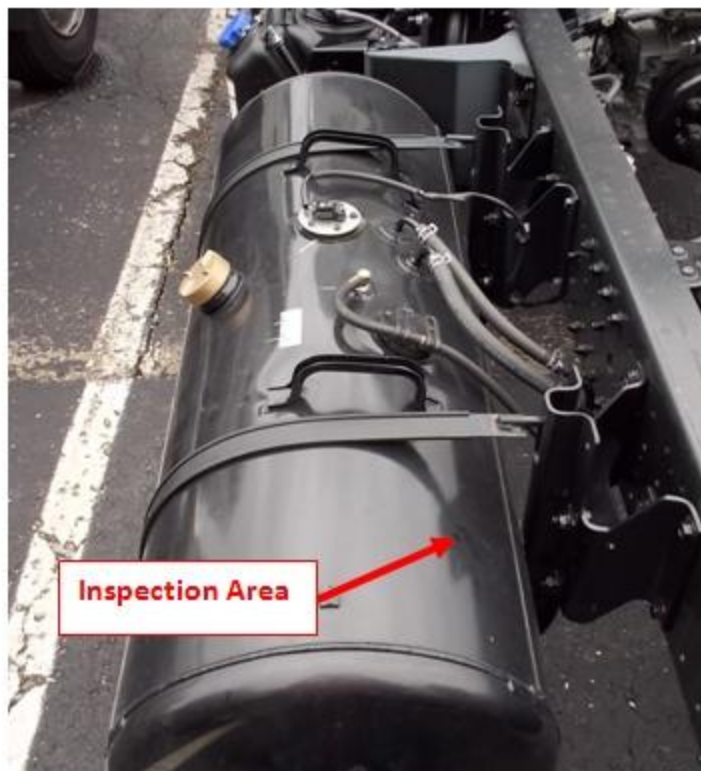
2. If equipped with a side fuel tank, inspect for potential damage and repair if necessary.
