**Document ID:** IK0500008  
**Revision:** 4  
**Created:** 12/21/2006  
**Last Modified:** 6/11/2014  
**Author:** James Santos

### Title: Lubrication to the Intermediate Steering Column Upper U-Joint

**Applies To: Model:** 4200 4300 4400 7300 7400 7500 7600  
 8500 8600

TSI Number: 03-05-01

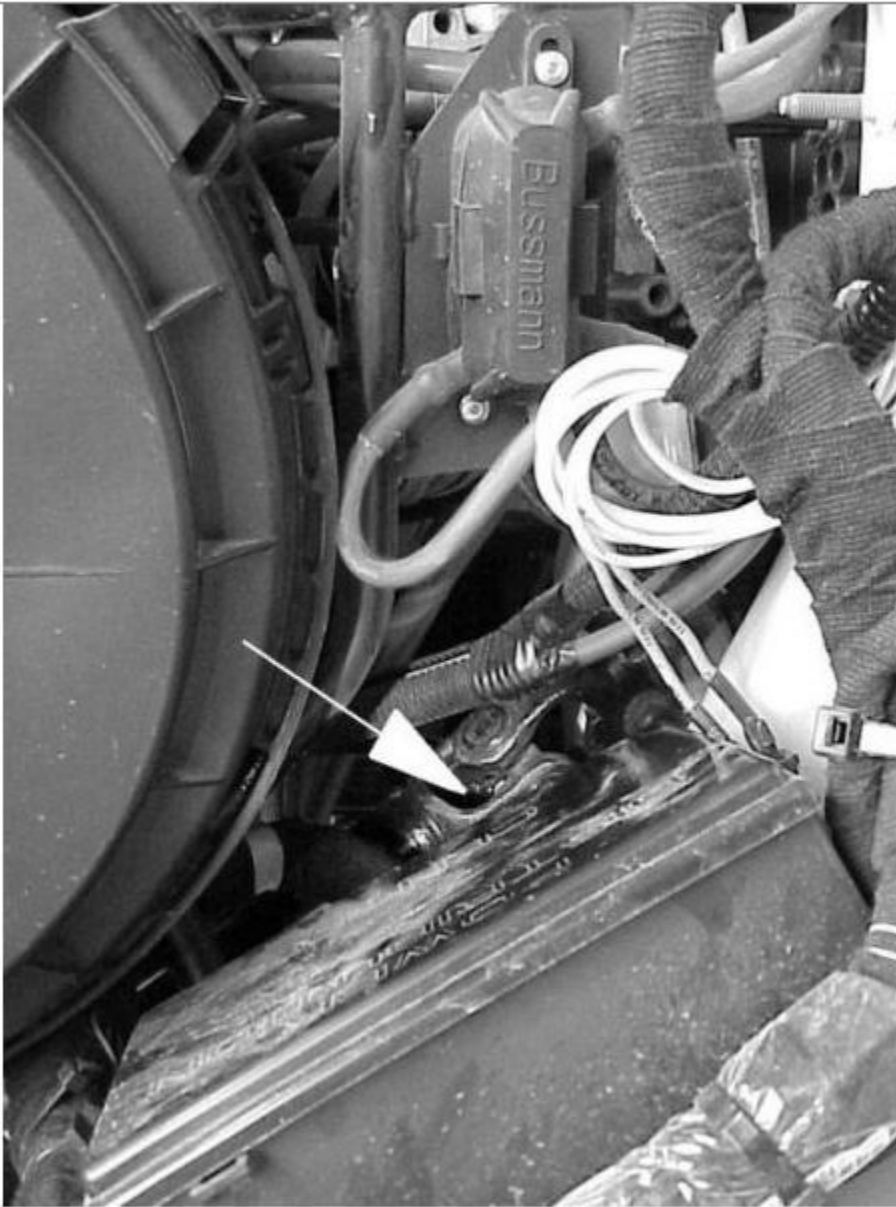
Figure 1. Location of Steering U-Joint

Information from the field indicates that the upper u-joint on the intermediate steering column is not being lubricated during maintenance intervals.

The u-joint is located near the power distribution center, on the left inner fender panel, as shown in [Figure 1](#). Sufficient grease should be inserted to purge the old grease so that clean new grease is visible at each u-joint trunnion. The steering column may need to be turned slightly to make the zerk fitting accessible ( [Figure 2](#) ).
