**Countries:** CANADA, UNITED STATES **Document ID:** IK0800485  
**Availability:** ISIS, FleetSIS **Revision:** 1  
**Major System:** ELECTRICAL SYSTEM **Created:** 3/20/2014  
**Current Language:** English **Last Modified:** 6/29/2014  
**Other Languages:** NONE **Author:** Chris Moody  
**Viewed:** 296

**Title:** Cluster Issues

**Applies To:** CE Bus, DuraStar, TerraStar, WorkStar, TranStar, ProStar, LoneStar, 9900i, PayStar

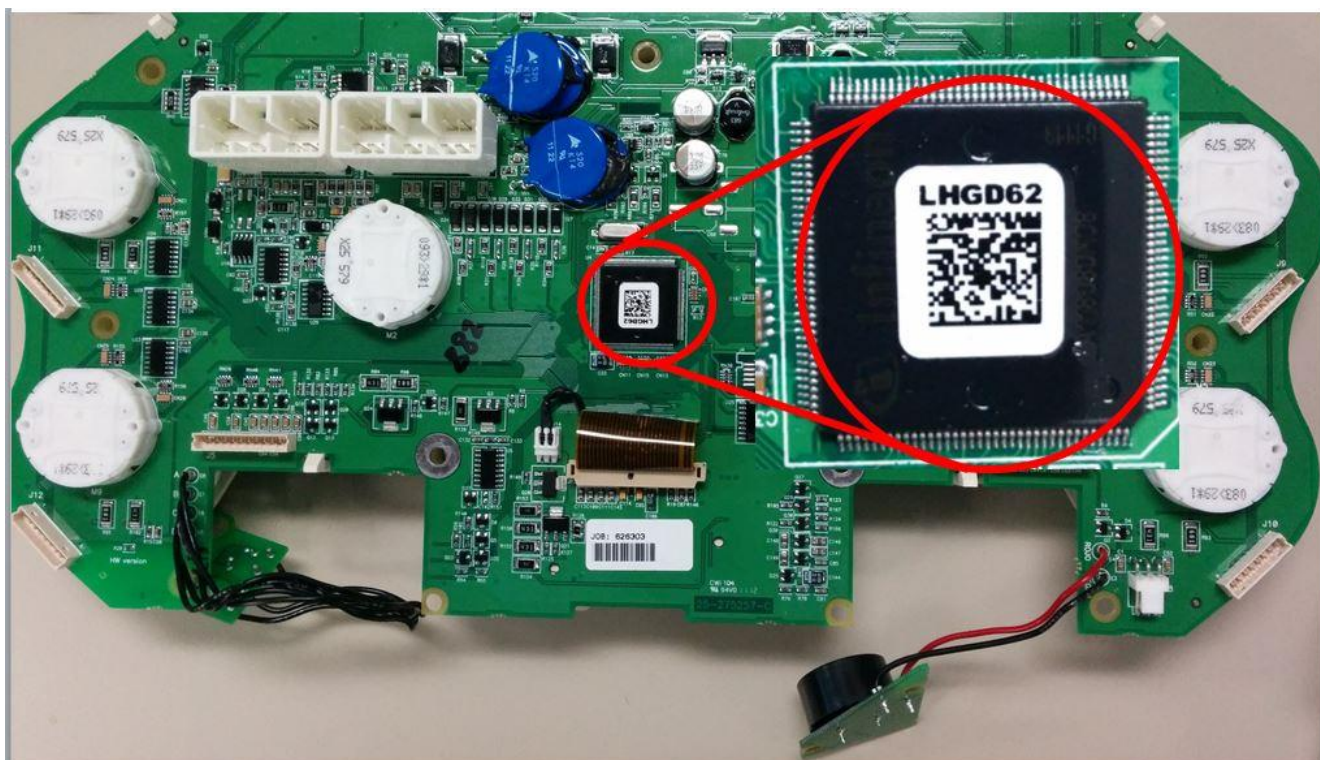
Common Cluster Software Version Identification Located on Back of circuit board. In this example, the software version is 6.2

The latest software for common cluster is currently 7.0

If it is determined the cluster needs to be updated, follow the procedure below for the applicable cluster you have.

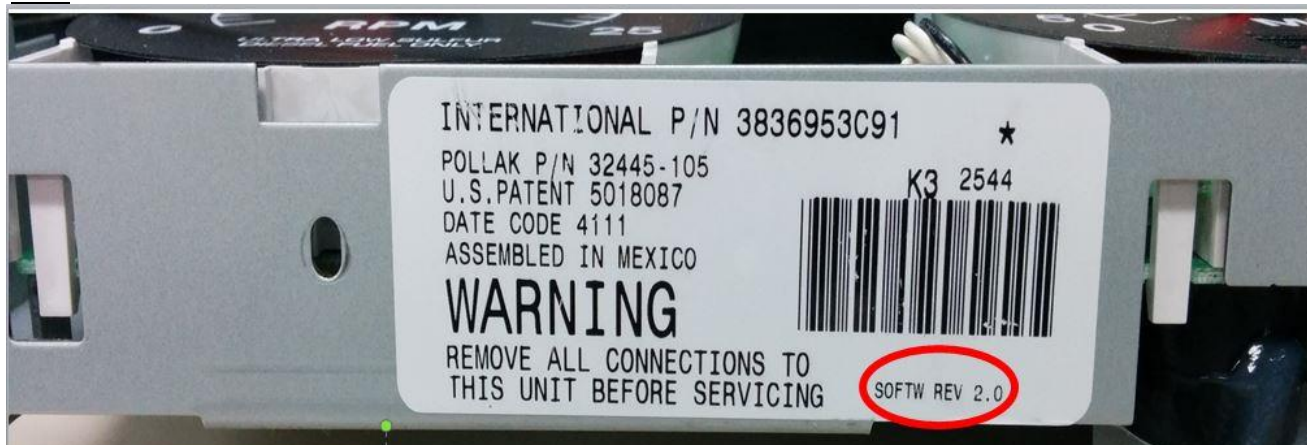
HDDL2 Cluster Software version.  
In this example, the version is 2.0

Currently, the latest HDDL2 cluster software is 3.5
