Countries: CANADA, COLOMBIA, UNITED STATES **Document ID:** IK1100031
Availability: ISIS, FleetISIS **Revision:** 7
Major System: CLUTCH **Created:** 10/29/2013
Current Language: English **Last Modified:** 6/17/2014
Other Languages: NONE **Author:** Matthew Boyer
Viewed: 3676

Title: Hard to Crank Condition on ProStar, LoneStar, and TranStar Vehicles

Applies To: ProStar, LoneStar, and TranStar Vehicles with Hydraulic Clutch Linkage and Solo Clutch

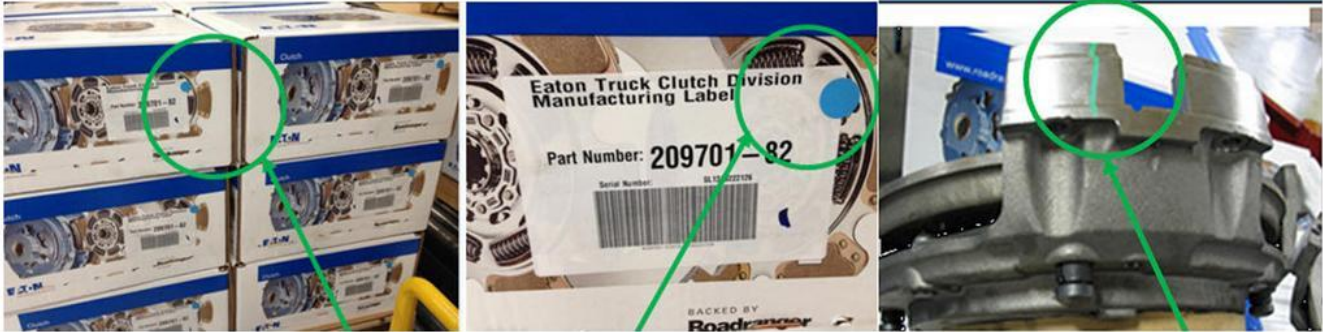
Compatible Replacement Clutches

Please see the below photos to identify a replacement clutch. These are clutches that must be used on all ProStar and LoneStar vehicles. Vehicles with a mechanical linkage system can continue to use clutches without the markings. All these clutches are certified to have a bearing gap above 0.530" at the Eaton end of line tester. These clutches can be identified by the following witness marks:

- A blue dot placed on the corner of the part label on the box
- A green line on the pressure plate ear nearest the cam tab

To ensure you receive a clutch that has a blue dot, please order a clutch from the PDC. When ordering the clutch, notate on the order " Please ensure the label on the clutch box has a blue dot on it, per IK1100031"
