**Document ID:** IK1200949  
**Revision:** 6  
**Created:** 9/24/2013  
**Last Modified:** 6/16/2014  
**Author:** Erik Wass

**Title: 2010 I-6 Exhaust Manifold Soot Accumulation and Operating Characteristics**

**Applies To: 2010 + MaxxForce DT, 9, 10 (ESN 3,300,000 and later)**

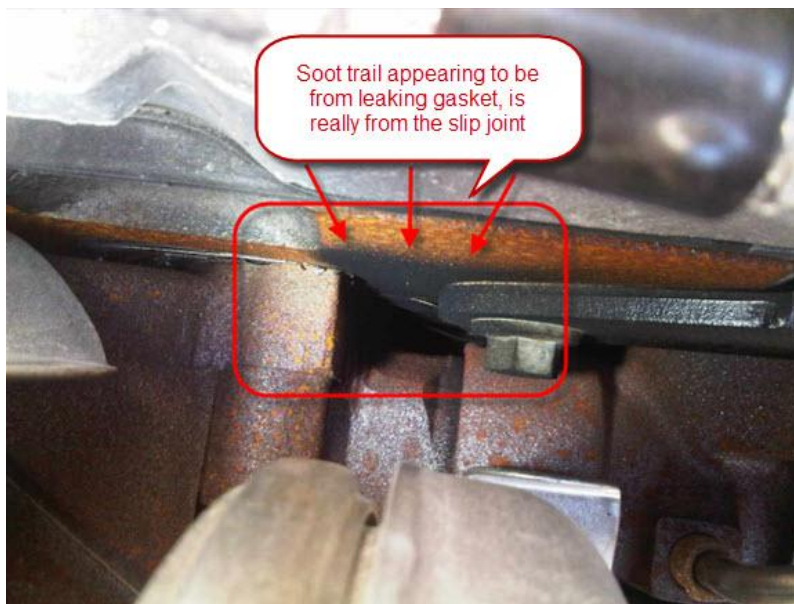
**Figure 1**

Soot trail from a slip joint upon visual inspection of the manifold: Note the close proximity of the soot trail in relation to the slip joint where the two manifolds come together. (Note the soot is not built up on the joint itself, just on the head surface)

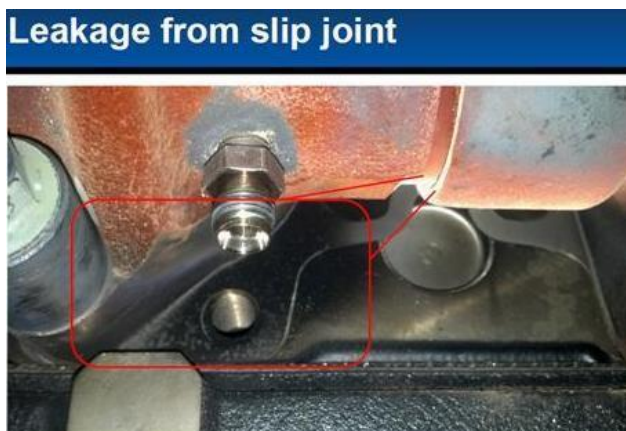
**Figure 2**

shows a slip joint with soot tracking on the manifold flange and cylinder head surface. This comes from the manifold slip joint, not from between the flange and cylinder head - often mistaken for a gasket leak. Once again, note that there is NO soot buildup on the joint itself.

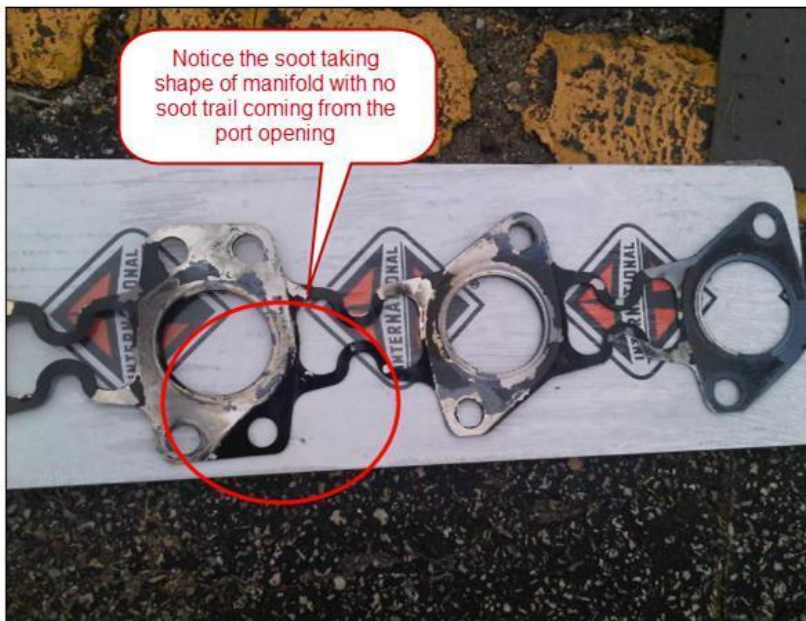
**Figure 3**

shows the soot did not leak from the gasket mating surfaces of the exhaust manifold to the cylinder head. Notice there is no soot from the inner seal ring of the gasket port to the outer edge of the gasket, just an outline of soot from the manifold flange. This soot buildup came from an exterior source. (i.e. fcy ring/slip joint leakage as shown above)

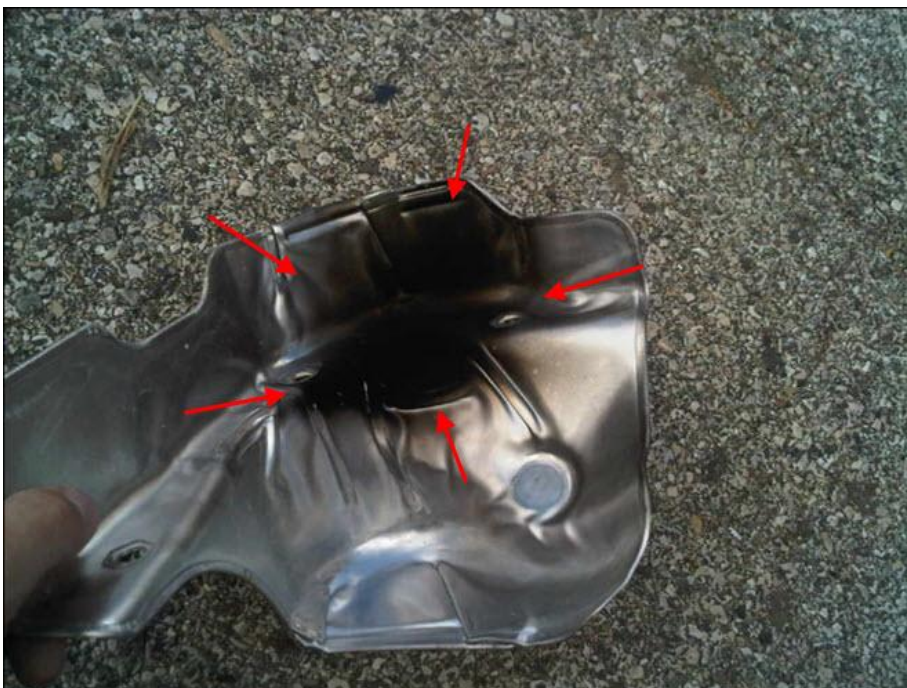
Figure 4

This is a heat shield (EGR 'gooseneck') connection at manifold. The source of soot at this specific location would be from the fey ring joint (slip joint), which seals up with thermal expansion. If the fey rings themselves are seized in place or damaged then replace them but please note that replacing the fey rings or the manifold may NOT eliminate soot buildup at this joint or under the heat shield. **NOTE: THIS WILL NOT CAUSE A REGEN OR PERFORMANCE ISSUE.**

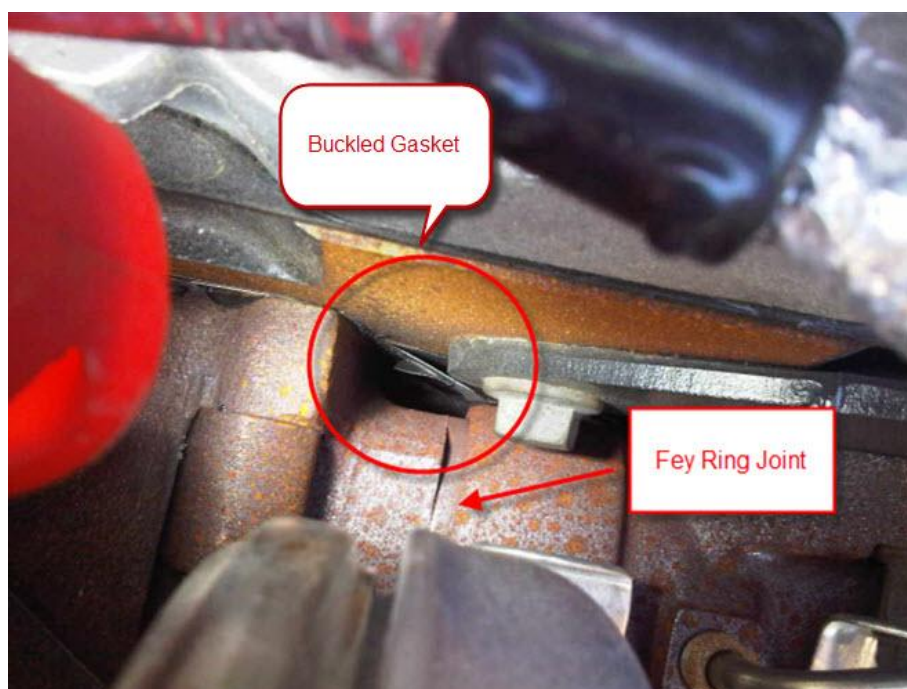
Figure 5

A "buckled" exhaust manifold gasket is not a defective part, the manifold and gaskets expand and contract (slide) with each thermal expansion cycle.

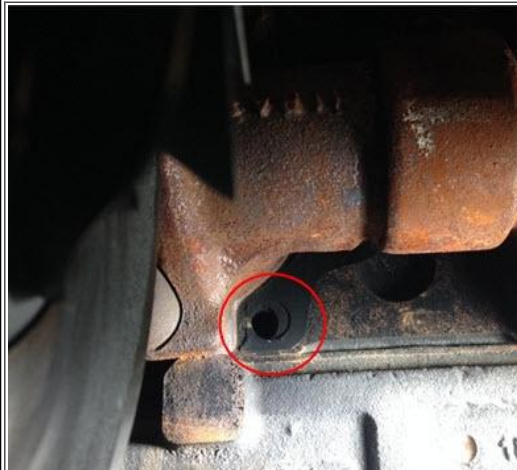
Figure 1 – "Good" manifold gasket, bottom of cyl. #3

This image shows **ACCEPTABLE** gasket position – if the gasket holes are aligned **HALFWAY OR BETTER** with respect to the bolt hole in the head, **DO NOT** replace the manifold or gasket. **WITHOUT** removing the manifold, install cuff seal 7092423C91. No case file/iApproval required.

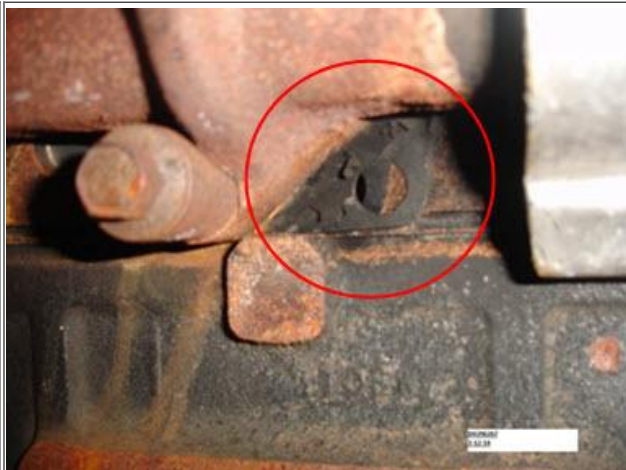
Figure 2 - "Bad" manifold gasket, bottom of cyl. #3

This image shows **UNACCEPTABLE** gasket position – if the gasket holes are misaligned or overlapped **MORE THAN HALFWAY** across the bolt hole in the head, then replace the manifold and gasket with kit: 7092501C92 or subsequent and install cuff seal 7092423C91 at the slip joint between ports 2 and 3. No case file/iApproval required.

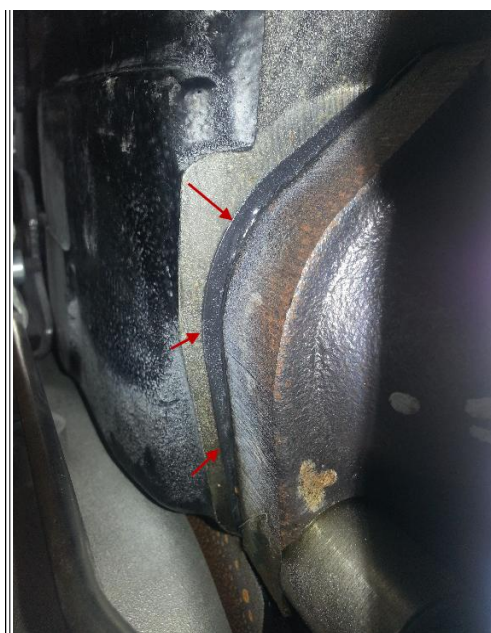
Figure 3 – "Good" manifold gasket, back of cyl. #6

This image shows **ACCEPTABLE** gasket position – If the gasket is protruding out from the manifold flange **LESS THAN 3/8"**, then **DO NOT** replace the manifold or gasket. **WITHOUT** removing the manifold, install cuff seal 7092423C91 at the slip joint between ports 2 and 3. No case file/iApproval required.

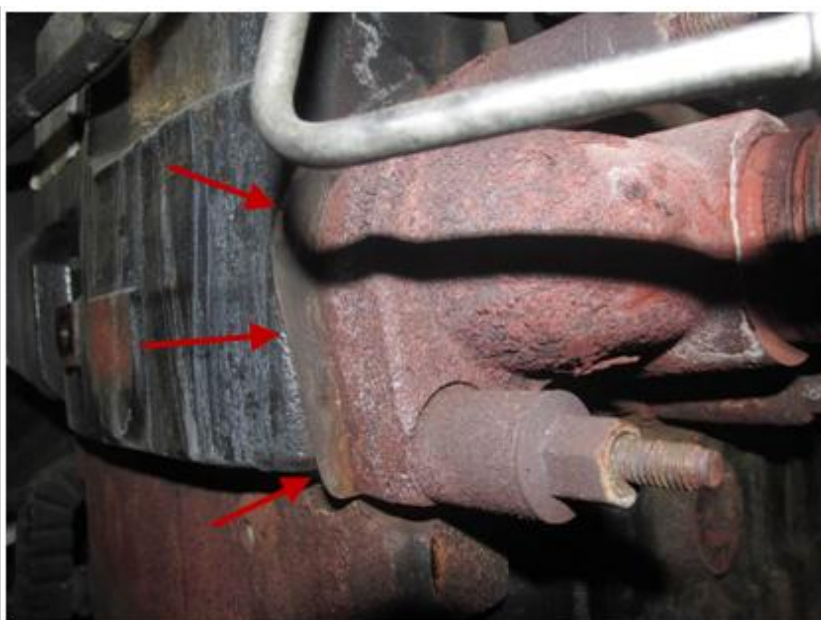
Figure 4 - "Bad" manifold gasket, back of cyl. #6

This image shows **UNACCEPTABLE** gasket position – If the gasket has protruded out from the manifold flange **MORE THAN 3/8,"** then replace the manifold and gasket with kit: 7092501C92 or subsequent and install cuff seal 7092423c91 at the slip joint between ports 2 and 3. No case file/iApproval required.
