**Title:** SPN 3055 FMI 17 FRP above maximum with minimum command Troubleshooting

**Applies To:** EPA 2010 MaxxForce 11 / 13 / 15 and N13

### SPN 3055 FMI 17 - FRP Above Maximum with Minimum Command

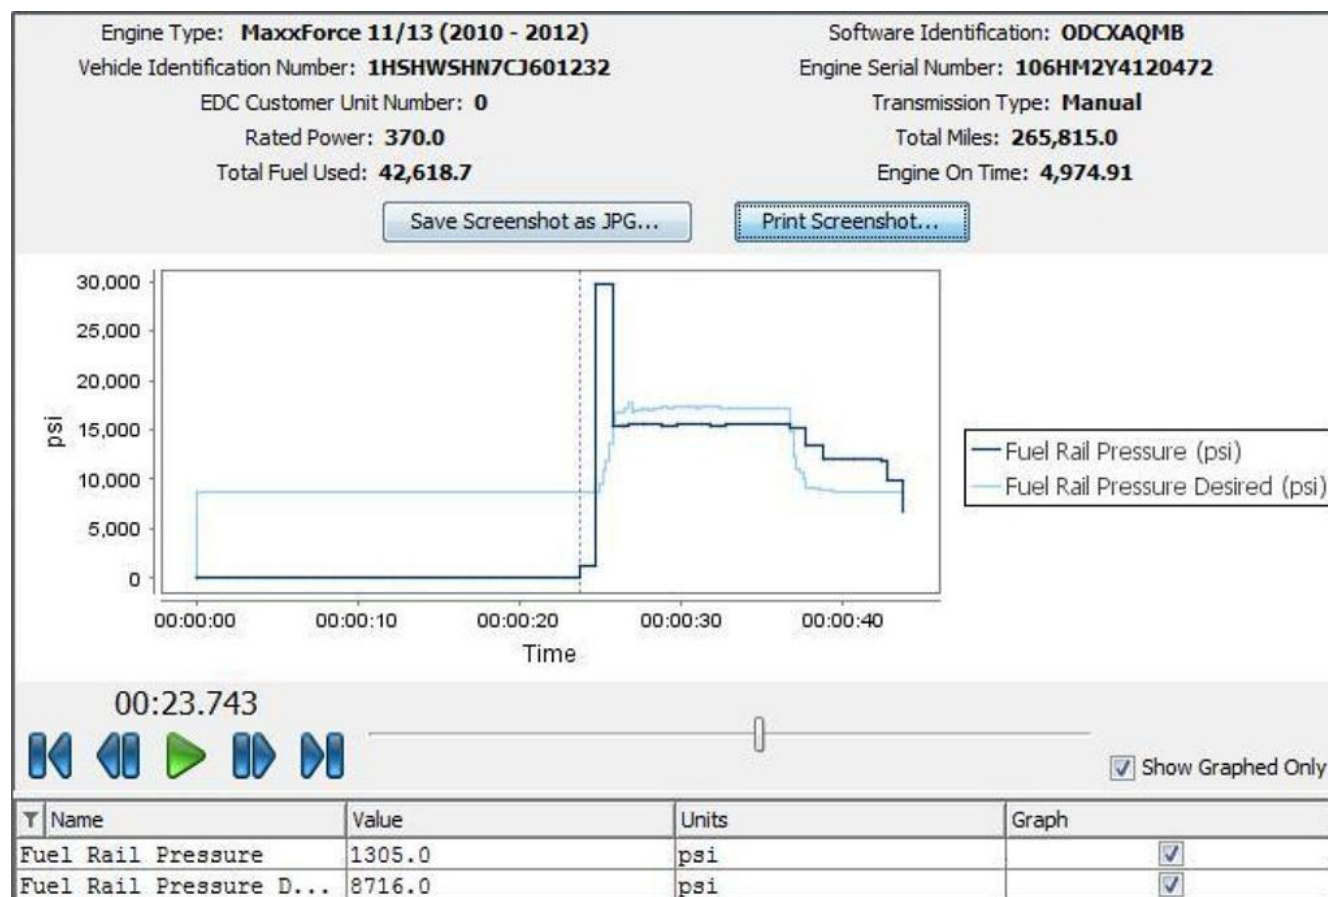
Figure A. FRP, AND FRPD.

| Step | Action | Decision |
|---|---|---|
| 4 | Check for a failed FPCV. Using EST, record a performance session snap shot of the vehicle idling for one minute. Open recorded signal and graph FRP and FRP desired data. Check graph for FRP over shoots.<br><br>Does the recorder plot look like Figure A?<br><br>(Viewing <a href="#">ServiceMaxx™ SnapShots</a> ) | Yes: Replace Fuel Pressure Control Valve.<br><br>No: Verify each step was completed correctly. Save snap shot and notify supervisor. |

| Qty | Part Description | Part Number | Step | SRT Description | SRT link | Model | HRs | Group | Noun |
|---|---|---|---|---|---|---|---|---|---|
| 1 | Fuel Pressure Control Valve (FPCV) | 7092109C91 | 4 | Electronic Engine Control Sensors / Valves (MaxxForce 11/13), Replace | <a href="#">A12-5034</a> | All Models | 1.5 | 12000-Engine | 454 |
