Title: Intake Air Temperature Sensor Damaged

Applies To: Prostar,Transtar, Maxxforce IBB

This article addresses the repair procedure for when the Charge-Air-Cooler Outlet Temperature (CACOT) Sensor fails or is damaged due to the hood making contact with the sensor.

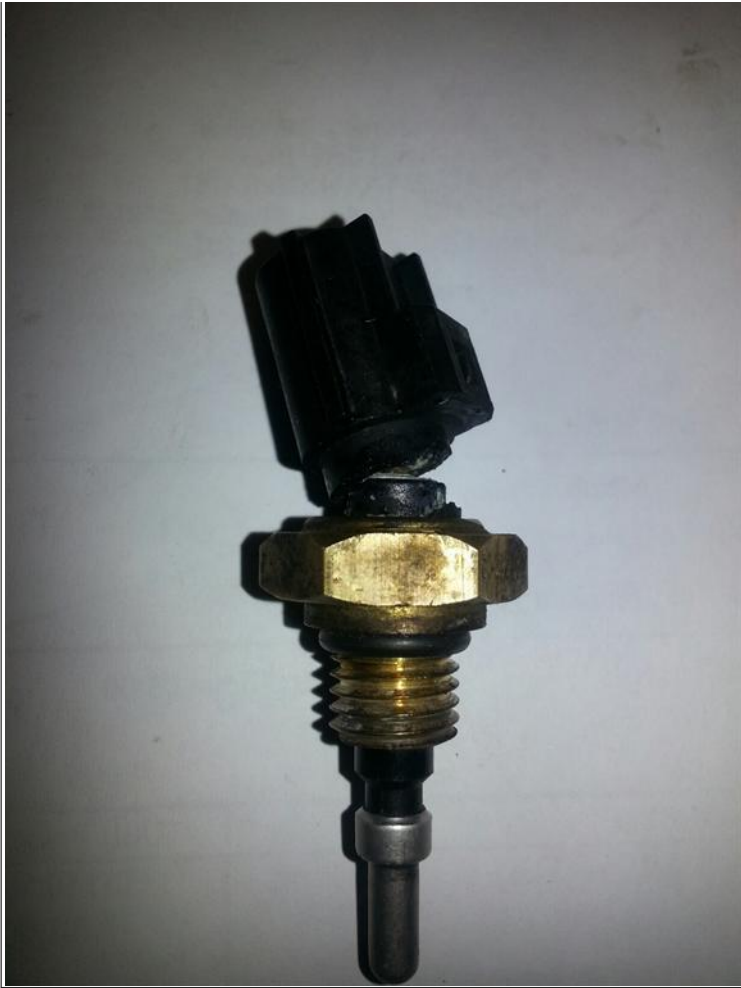
1. If you have one or more of the above DTC's inspect the sensor for damage. Look for cracks in the sensor or damage from rubbing the hood. See figure #1 for example of a broken sensor.
2. Inspect the inside of the hood for markings from rubbing the CACOT sensor. See figure #2 for an example of hood rubbing marks.
3. If the hood is rubbing the sensor then follow the below repair procedure. If there are no signs of rubbing or a broken sensor then diagnose the codes per the diagnostics manual.

Figure #1: Broken CACOT Sensor

1. Print out the correct template depending on whether you have a Prostar or Transtar
 - [Prostar Template](#) (See figure 3 for proper placement.)
 - [Transtar Template](#) (Same as figure 3 only the amount of material taken off will be different)
2. Cut out the center along the lines given
3. Insert the hole over the corner of the hood reinforcement and mark it off
4. Cut the corner of the hood reinforcement off
5. Patch the hole with SMC (Close Mold Fiberglass)
6. Verify the repair is correct and there are no leaks in the hood.

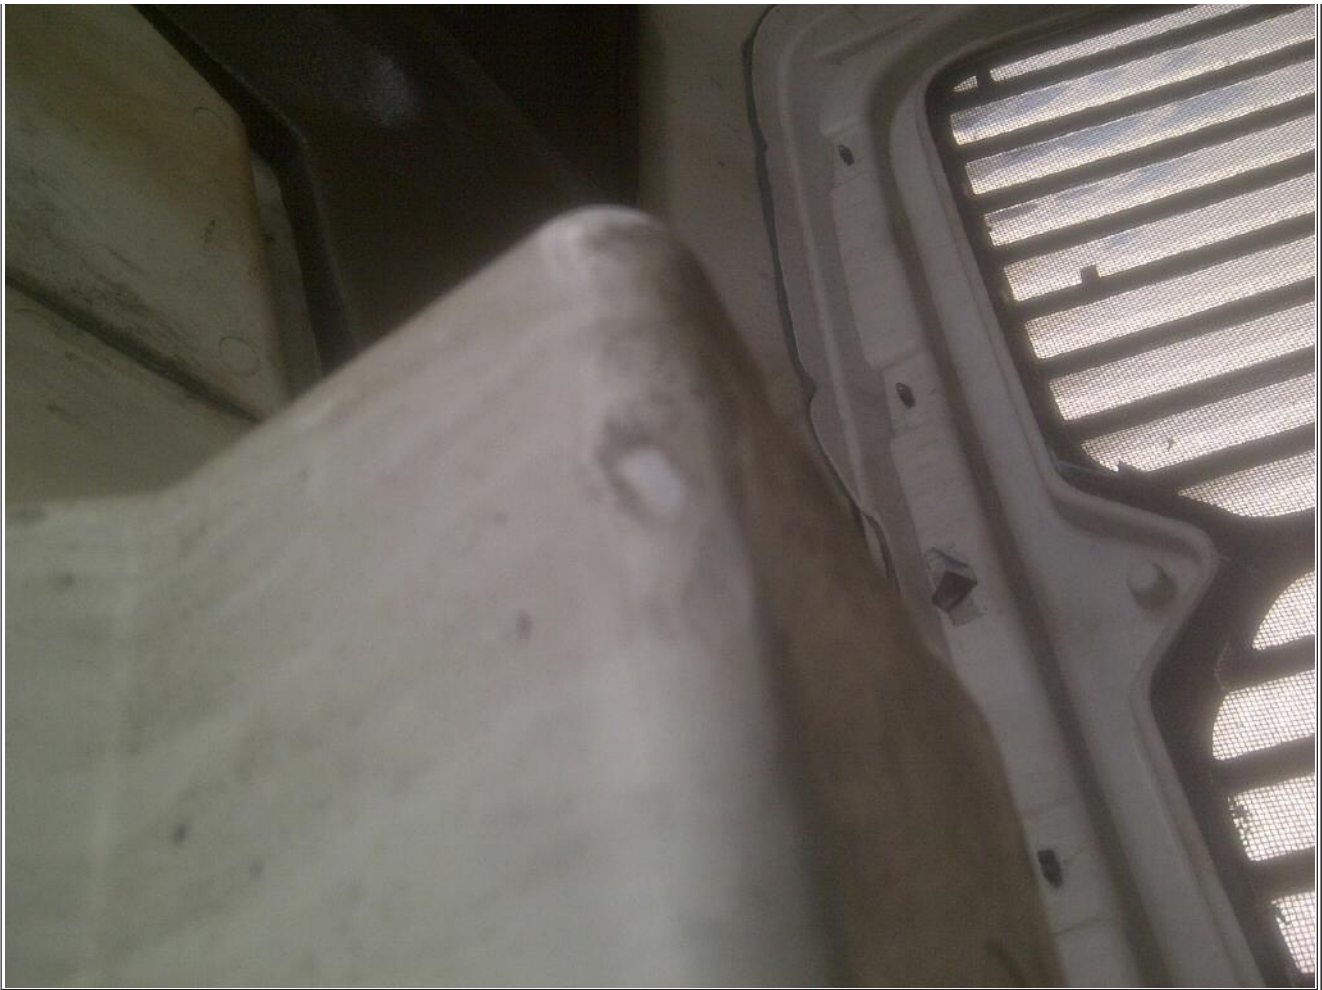
Figure #2: Hood Rubbing Mark From Sensor

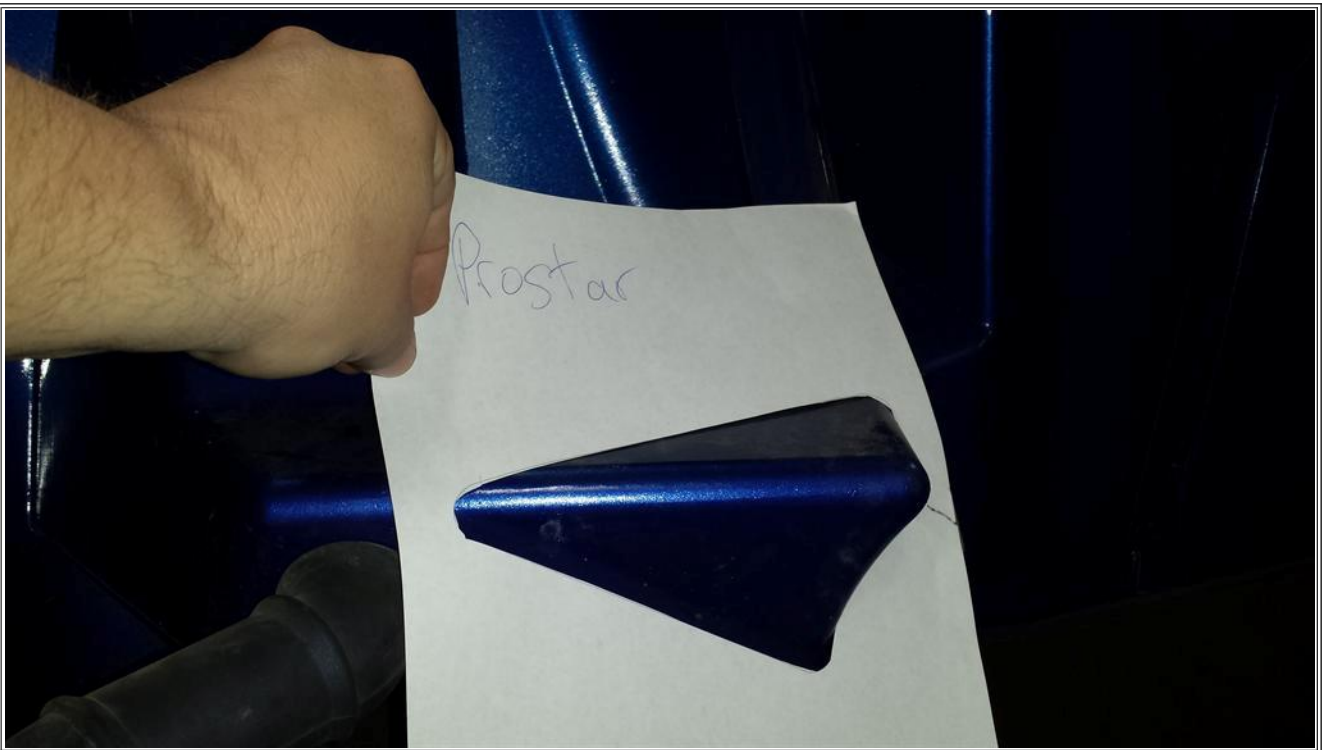
Figure #3: Prostar Template Example
