## WE34 - Checking Gap Dimension of Front Door and Reworking if Necessary (Workshop Campaign)

Model Line: **Macan**

Model Year: **As of 2014 up to 2015**

Concerns: **Gap dimension of front doors**

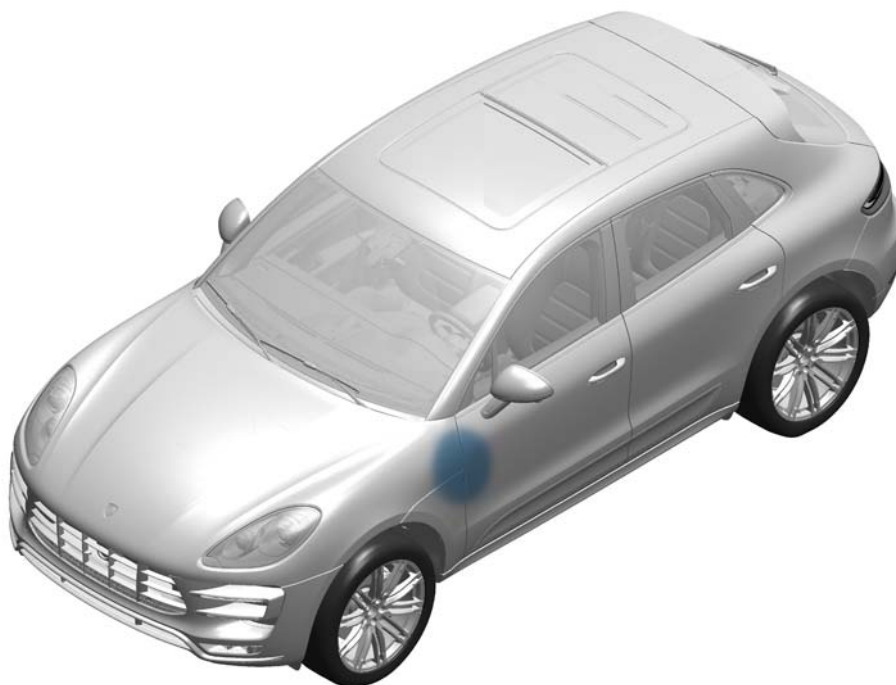
*Checking gap dimension of front door*

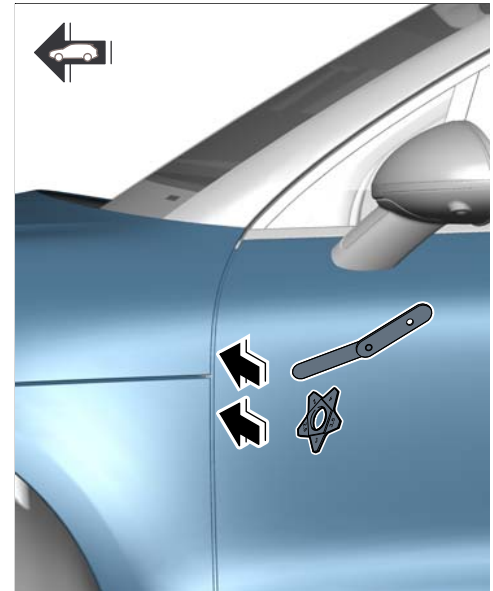
Checking gap dimension

- 1 Check gap dimensions and joint areas between the front door, front lid and fender ⇒ *Checking gap dimension -arrows-* using a star gauge in accordance with the joining plan with the front door/lid closed.

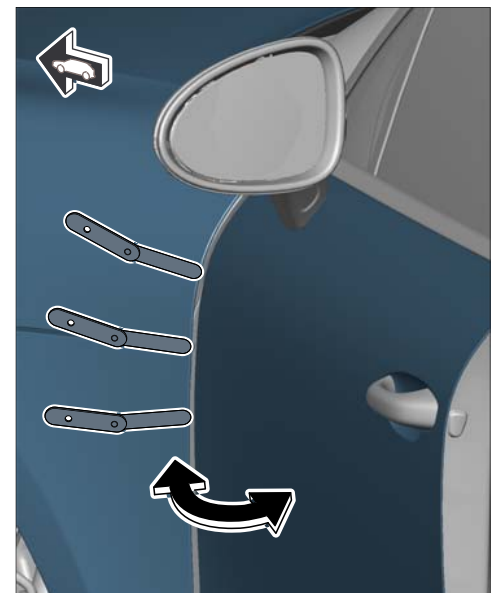
Checking gap dimension

- 2 Open the front door step-by-step and measure the gap between the front lid and door and the fender and door along the entire front door gap using a feeler gauge.

The clearance must always be at least **1.0 mm** along the entire height of the door.

- If the gap dimension is sufficient (**1.0 mm or more**), no further action is required. ⇒ **End of checking measure (Scope 1), continue with Step 3.**
- If the gap dimension is not sufficient (**less than 1.0 mm**), the front lid/wing must be adjusted first, then the front door in accordance with the joining plan. ⇒ *Technical Information 'WE3400 Adjusting front lid, door/wing'*.

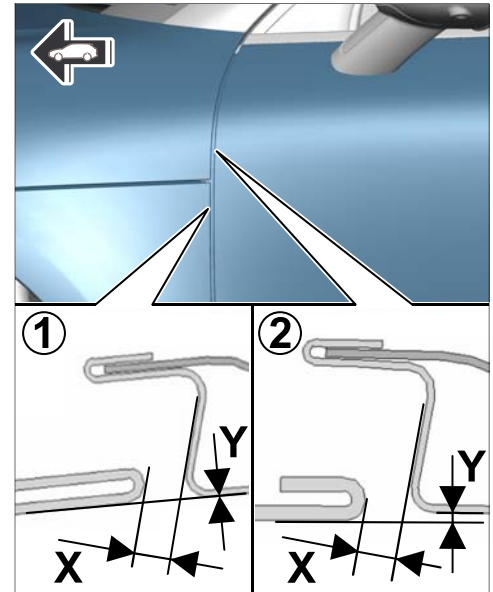
Adjusting front lid

Inset 1 = Gap dimension and offset of door with respect to fender.

**Gap dimension X 4.1 mm +/- 0.5 mm Gap dimension Y 0 mm**

Inset 2 = Gap dimension and offset of door with respect to front lid.

**Gap dimension X 4.1 mm +/- 0.5 mm Gap dimension Y 1 mm**

- 4 Adjust the front lid and the fender and front door, if necessary, as described in the Workshop Manual.

Adjust the front lid, see Workshop Manual ⇒ *Workshop Manual '552215 Adjusting front lid'*.

Adjust the front door, see Workshop Manual ⇒ *Workshop Manual '575115 Adjusting front door'*, and pay particular attention to the following gap dimensions:

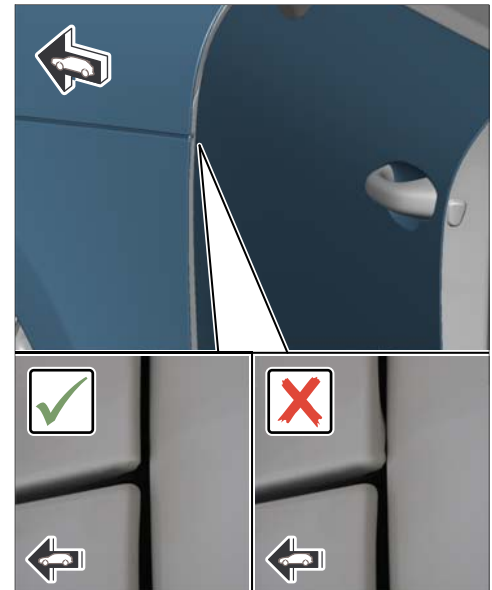
*Gap dimension comparison*

- The additional warranty claim must be processed by specifying ⇒ **Damage code 5522 097 000 1**.
  - Document the work with pictures (reworked flange seam before painting) in the PQIS job by specifying **55220** (front lid) and/or **50550** (wing) under "Location" and **1714 - touching, rubbing** (Repair in accordance with PAG instructions) as the "Damage category".
  - Specify that the repairs were carried out due to campaign WE34 under "Further Information" on the PQIS job.
- 7 Measure the marked area of the flange seam on the inside of the front lid/fender using a caliper gauge. The setpoint dimension must not exceed 4.0 mm.
- If the flange seam is **less than 4.0 mm**, the front lid and fender adjustment must be checked again.
  - If the flange seam is **greater than 4.0 mm**, it must be reworked. ⇒ **Continue with Step 8**.
