Cause of Fault in Power Distributor (in front left wire harness): Rework Required (21/14)

Model Line: **Panamera**

Model Year: **As of 2010 up to 2013**

Concerns: **Power distributor**

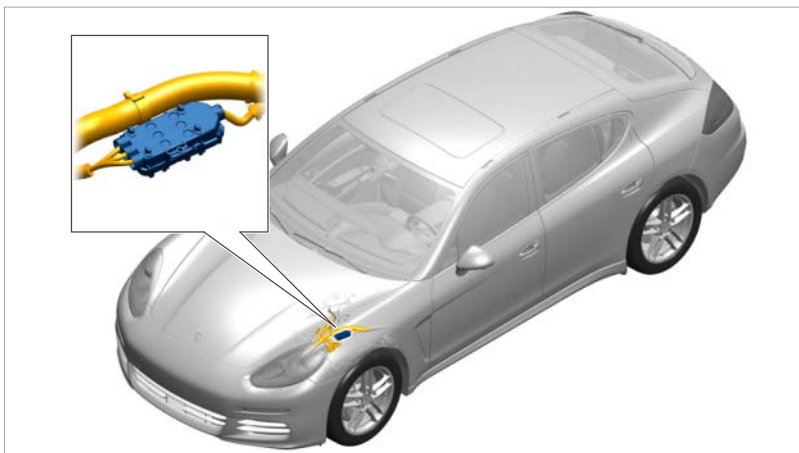
Figure 1

Information: **In the event of complaints relating to the overall power supply on the vehicle and if "Connections in power distributor corroded" is discovered as the cause of the fault, the cover on the power distributor (⇒ Figure 1) must be sealed using new sealant.**

Complaints can include various malfunctions in the vehicle electrics (fault in PCM, failure of power windows or similar problems) or various error messages displayed in the instrument cluster.

Action Required: Clean corroded parts of the power distributor and seal the sealing face for the power distributor cover with "Union cement" sealant.
