| Bulletin No.: | SB-14-001 |
| Issue Date: | 08/25/2014 |

## SERVICE BULLETIN

In the event that a cracked or broken cab step exists on the driver's side or passenger side of the subject vehicles, a revised cab step has been released with a reinforcement pipe that will increase the robustness of the cab step to reduce the chance of repeated cracking or breaking. Vehicles built on or before January 18, 2013 will also require a reinforcement bolt be installed in the multi-layer steel flange on both sides of the vehicle.

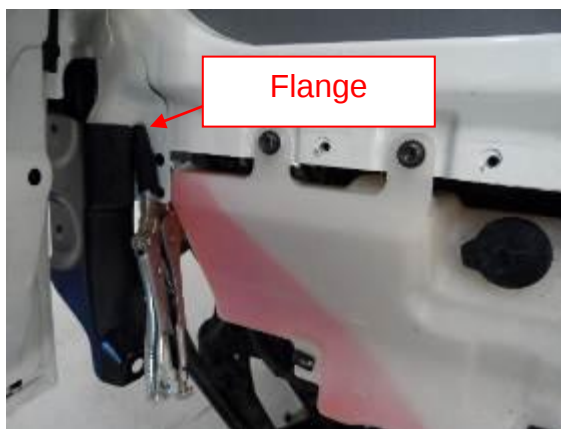
- On the driver's side, locate the flange near the front of the bottom of the cab. The spot weld may be broken. Regardless of whether or not the spot weld is broken, install Vice-Grips to lock the flange together in preparation for drilling through the multi-layer steel flange.

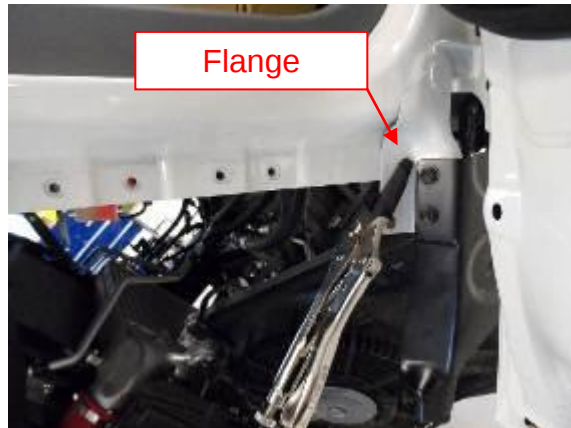
10. On the passenger side, locate the flange near the front of the bottom of the cab. The spot weld may be broken. Regardless of whether or not the spot weld is broken, install Vice-Grips to lock the flange together in preparation for drilling through the multi-layer steel flange.

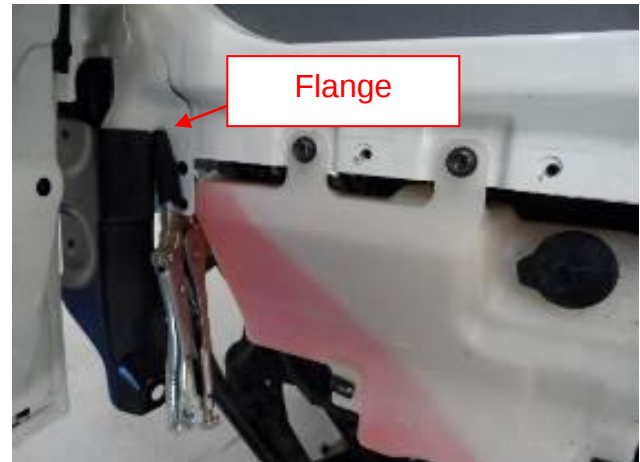
- On the driver's side, locate the flange near the front of the bottom of the cab. The spot weld may be broken. Regardless of whether or not the spot weld is broken, install Vice-Grips to lock the flange together in preparation for drilling through the multi-layer steel flange.

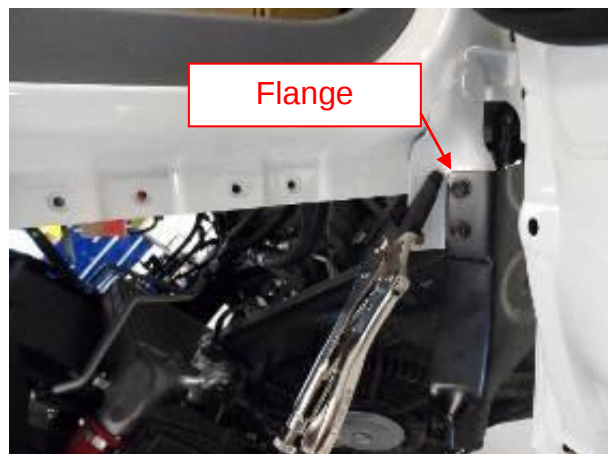
13. On the passenger side, locate the flange near the front of the bottom of the cab. The spot weld may be broken. Regardless of whether or not the spot weld is broken, install Vice-Grips to lock the flange together in preparation for drilling through the multi-layer steel flange.
