Tech Tip No:	TT-14-016
Group:	99-Miscellaneous
Issue Date:	6/27/2014

TECH TIP

2011MY – 2014MY Exhaust Combustion Chamber with Loose Insulation

2011 through 2014 model year NV8J, NJ8J, and NF8J conventional trucks.

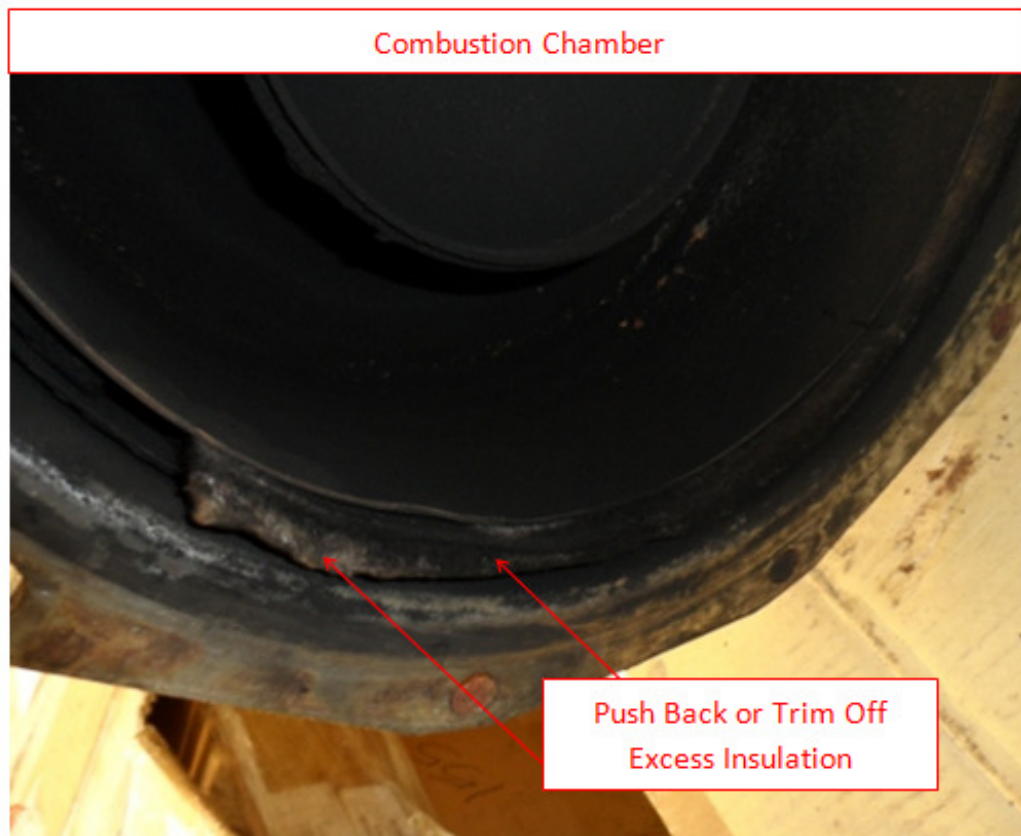
During service of the exhaust aftertreatment system, the technician may visually find that the insulation within the outer shell of the combustion chamber is pushing out or loose. In the event that loose insulation is found, it is recommended to push the insulation back into the outer shell, or use a utility knife to trim off the excess insulation material. Replacement of the combustion chamber for loose or missing insulation is not recommended and is not a warrantable repair. Missing combustion chamber insulation will not cause any adverse functional effects with the exhaust aftertreatment system.
