| REFERENCE: | Nova Bus Manuals |
| RS N°: | MQR 7621-712 |

| SUBJECT: | Rear engine access door scissor hinges |
| JUSTIFICATION: | The rear engine access door may not close properly. |

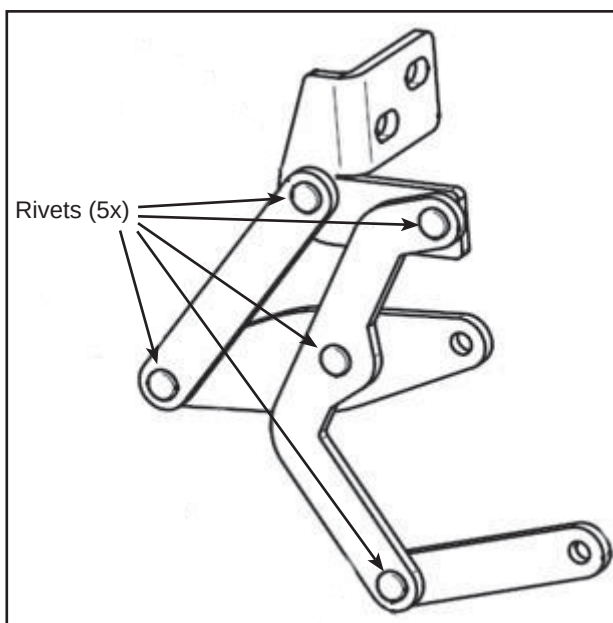
Figure 1 - Rear Engine Access Door Scissor Hinge

- 1.1. Open the rear engine access door.
- 1.2. Check for missing or loose rivets on both engine door scissor hinges. See Figure 1. Otherwise, go to step 1.12.

- 1.3. Remove the faulty scissor hinge(s) from the vehicle. Retain the hardware.
- 1.4. Remove the five rivets from the hinge using a grinder or a press drill with a 1/4 in. drill bit. See Figure 1.
- 1.5. Enlarge all rivet holes using a press drill with a 1/4 in. drill bit.
- 1.6. Thoroughly deburr each hole.
- 1.7. Apply a small amount of bearing grease, or equivalent, on the hinge pivot points and on then N8901819 shoulder screw shoulder section. See Figure 2.
