# Service Bulletin No. 403

| MODEL | J4500 Series | TYPE | Field Change Program | SECTION/GROUP | 3-Body | DATE | Mar. 18, 2014 |
| SUBJECT | DD13 DPF CRADLE | | | | | | |

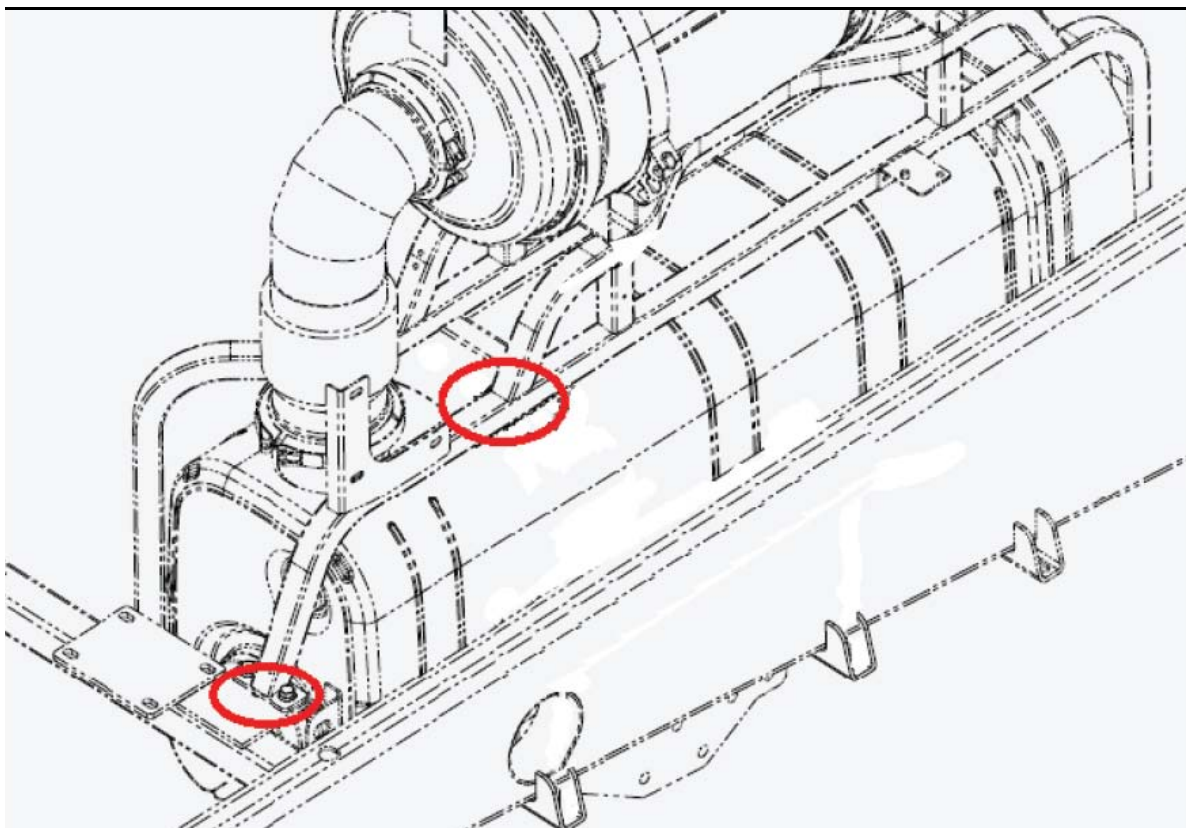
**Figure 1.**

Motor Coach Industries ("MCI") has become aware that the diesel particulate filter (DPF) cradle may exhibit signs of fatigue and cracking.

Failed welds as a result of cradle lateral movement.

*Visually inspect the two ( 2 ) areas circled in Figure 1.*

*Upon visual inspection, if signs of cracking are evident at one or both locations identified in Figure 1, contact the MCI Fleet Support Technical Center at 1-800-241-2947 for further information.*
